## Geohazards Risk Assessments

Landslides in Honduras triggered by rainfalls in 2008

October/November 2009

**Consolidated Report by Åsa Granath and Markus Lundkvist**

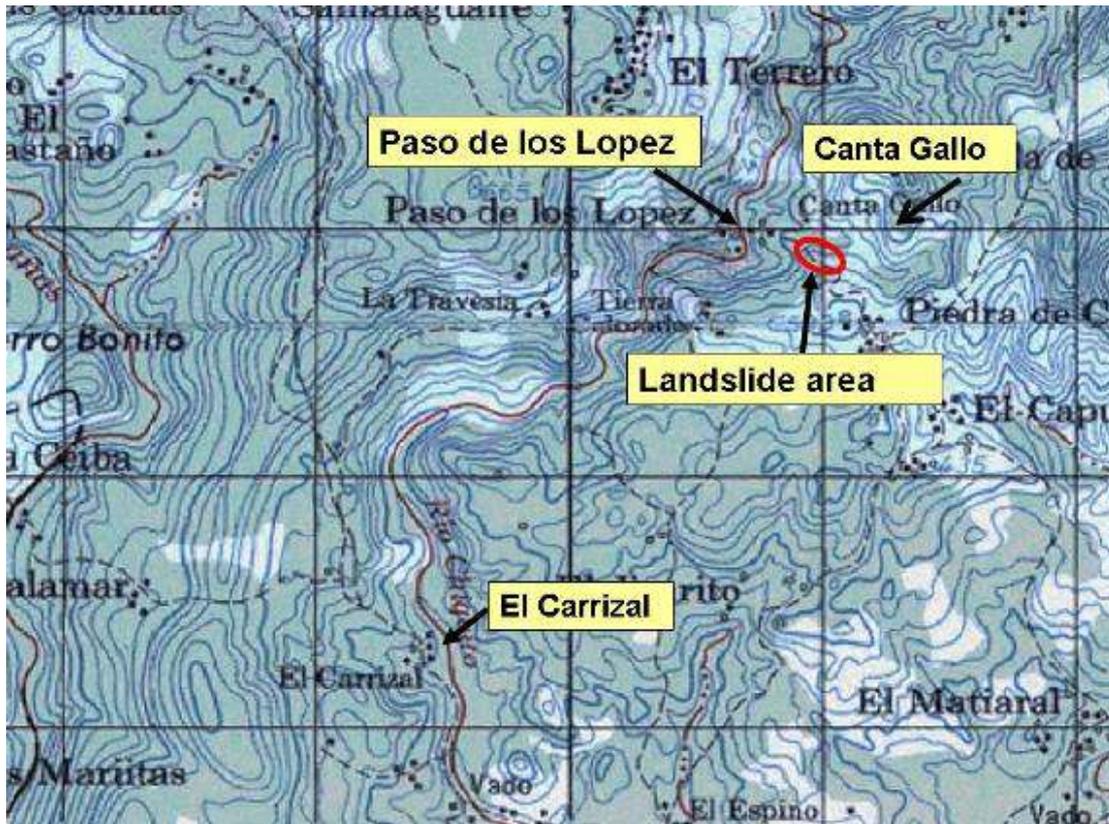
Figure 4. Liure, El Paraiso. Topographic map showing the site and evacuated villages.

The Liure landslide site clearly showed landslide processes such as subsiding soil and frequent deep and wide cracks in the ground. Prolonged rain might trigger new movements of the landslide. Seismic activity might also cause soil movements, which could take place all year round.

The village Paso de Los Lopes might be at risk of being affected by the landslide. The eastern side of Rio Chiquito is most likely to be affected. The risk can be assumed to be higher during the rainy season. Monitoring of soil movement should be performed along the landslide slope. The monitoring is a priority and should start as soon as possible. In addition, it is recommended to undertake a detailed slope stability assessment. If the measurements show slow or no soil movement, it should be safe for the inhabitants in Paso de los Lopez to move back, at least temporarily, until the next rainy season.

The inhabitants in the village El Carrizal can move back. However, a contingency plan should be conducted for El Carrizal and other settlements near Rio Chiquito and downstream from the landslide.

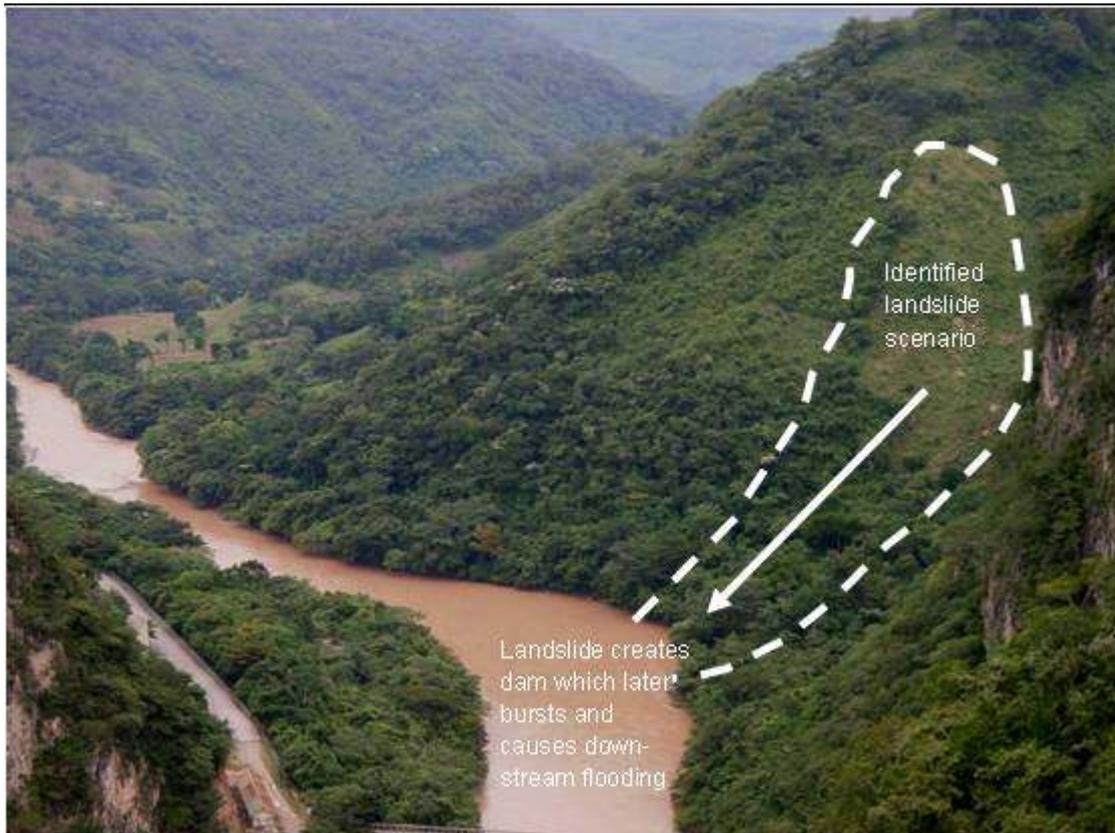
Figure 5. Assessed slope south of the El Cajon Dam.

As no landslide had taken place recently, in spite of recent deforestation and heavy rains, the slope was regarded as relatively stable at the time of the assessment. Any movement on the steep deforested slope is likely counteracted (i.e., slowed down) by an apparently stable, large and densely forested area below. The probability of a landslide subsequently leading to inundation downstream was therefore regarded as small.

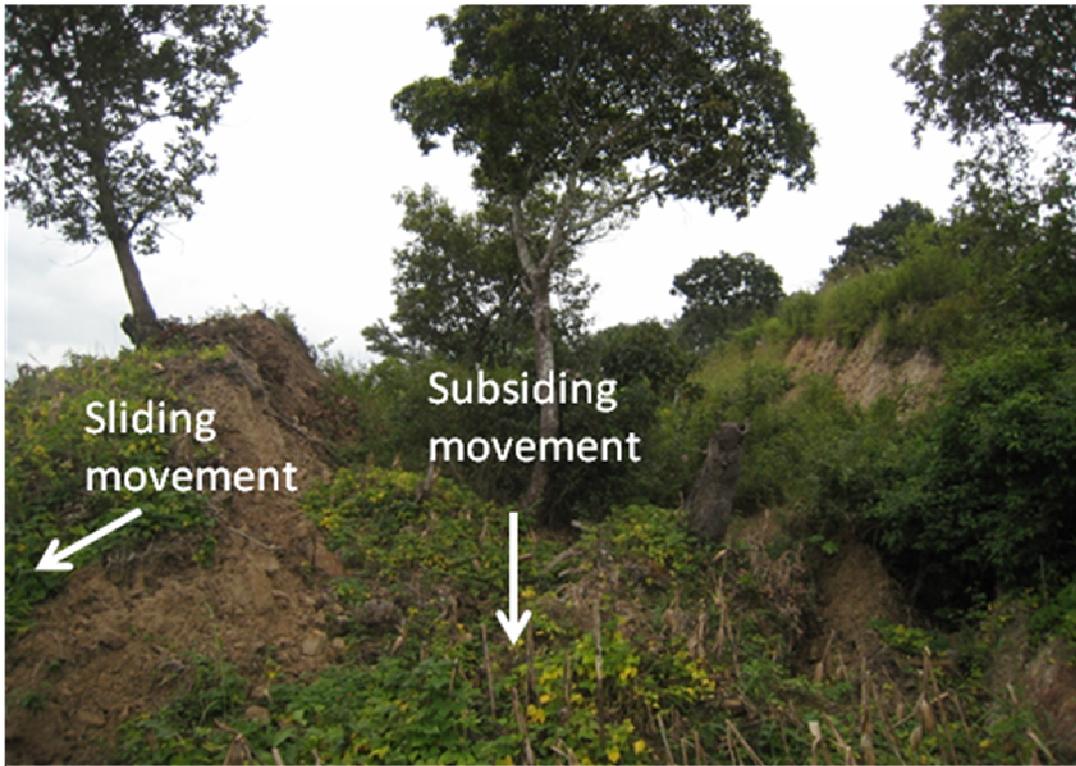
In Matapalo, Department of Comayagua, activation and extension of an old rotational landslide caused cracks in a couple of houses in late October 2008. Although 40 houses were evacuated as a precautionary measure, the extent of the damage was limited.

The sporadic landslide movements at this site are generally slow and the probability of human casualties can be regarded as low. It is suggested that inhabitants in unaffected houses

Figure 6. Recently extended fault in the landslide in Matapalo village.

In the long term, the movement is relatively deep-seated and landslide reactivation is likely to take place in the event of extreme precipitation. At this site, it may be difficult to prevent landslides from occurring by undertaking short-term measures, as the probability of significant movement annually is relatively low. It should be kept in mind that precipitation levels during both Hurricane Mitch in 1998 and the rainy season of 2008 are exceptional, and no movements seem to have taken place in the years in-between.

However, with every new landslide reactivation, the preconditions for further landslide activity might change. Future movements are more likely to cause material damage than human casualties.

can move back. However, prior to the next rainy season, when the probability of a landslide will be higher, damaged houses should be evaluated by a structural engineer to determine the possibility to return, or to abandon the houses.

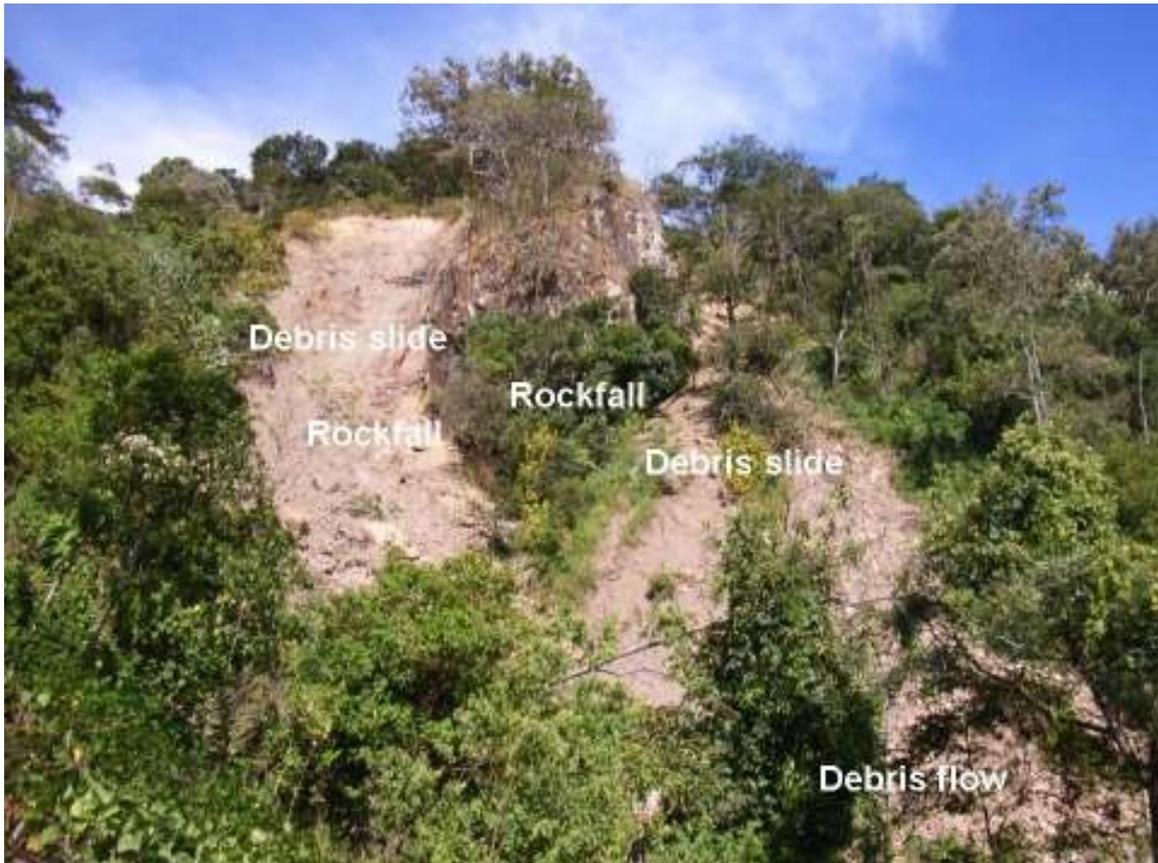
A landslide in Goascorancito, Department of Valle, was activated in October 2006 by a combination of prolonged rainfall and seismic activity.

Figure 7. The activated landslide area in Goascorancito with descriptions of various landslide processes.

Below the landslide, there is a low probability of one particular house to be affected by a rockslide and/or debris flow. The situation should be further analyzed, including a detailed estimation of the landslide propagation direction and assumed paths of debris flows and rock falls.

The possibility of falling rocks and debris from the assessed landslide affecting other houses in Goascorancito is also assumed to be low. The town of Calidad, which is located approximately 5 km west of the landslide, is unlikely to be affected by falling rocks and debris flow from the studied landslide.

A more extensive study, as well as monitoring of the landslide site, are recommended. The study should comprise a geological investigation of the active landslide as well as the area above the rock outcrop. The landslide and the surrounding hills should also be monitored and inspected regularly regarding leaning trees, fissures, and rock falls.

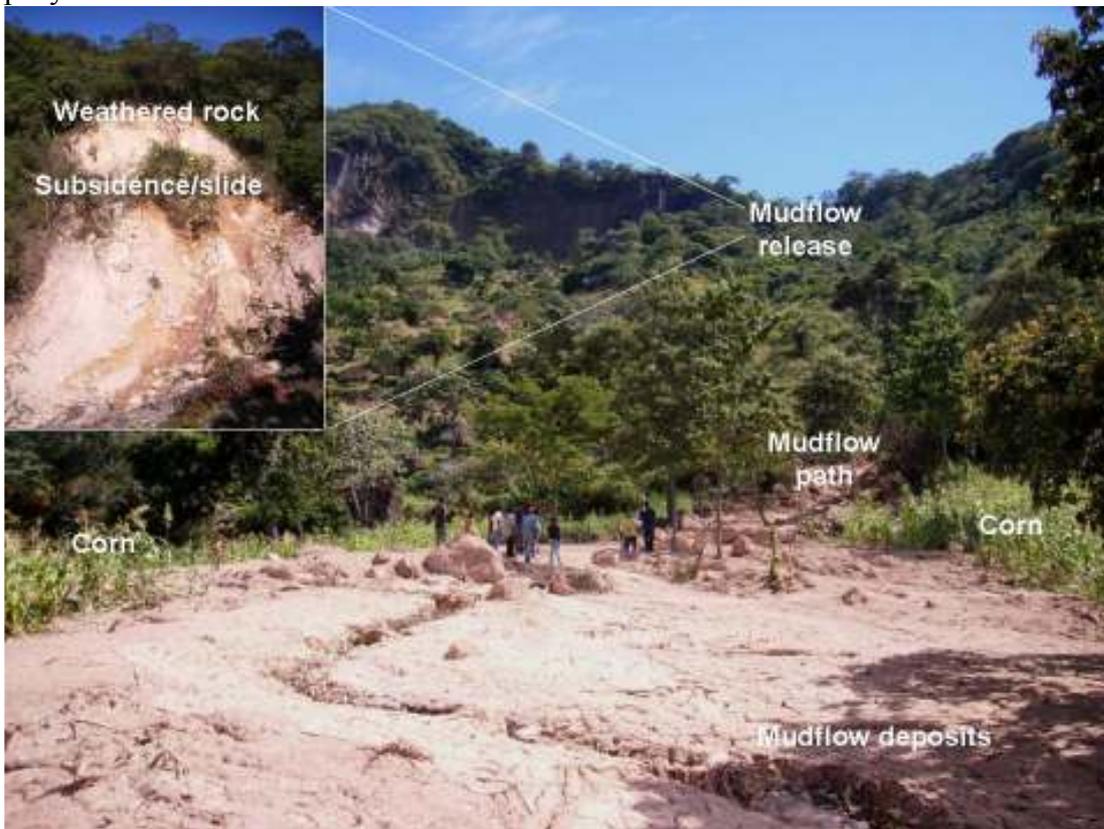
Prolonged and intense rainfall initiated an extensive mudflow and debris flow down the slopes near the village of Moropocay, Department of Valle, on 23 October 2008. The mudflow ended relatively near a house and covered some agricultural land. A couple of houses near the landslides were evacuated, but the inhabitants have now returned.

The slopes of Moropocay hill have previously been affected by landslide activity, related to Hurricane Fifi (1974) and Hurricane Mitch (1998). The probability of new landslides is high. The village of Moropocay, its surroundings, and the connecting road are situated in

the direction of a possible landslide movement and are thus at risk of being affected. Landslides have so far coincided with prolonged and intense rainfall. Seismic activity might also be a triggering factor. Seismic activity during the rainy season and saturated soils can amplify the risk for landslides.

Figure 8. Mudflow release zone and path are illustrated in the picture. Eastern landslide in Moropocay seen from the mudflow outlet.

Geological and hydrogeological investigations are recommended to form a basis for improved land use planning.

The landslide area and the surrounding hills should also be monitored, focusing on leaning trees, fissures, erosion and rock falls. Dense vegetation below the landslide should remain in place, as that will prevent and reduce accelerated debris flow. The landslide sites should be avoided due to the risk of being hit by falling stones and debris. The risk is especially high during the rainy season.

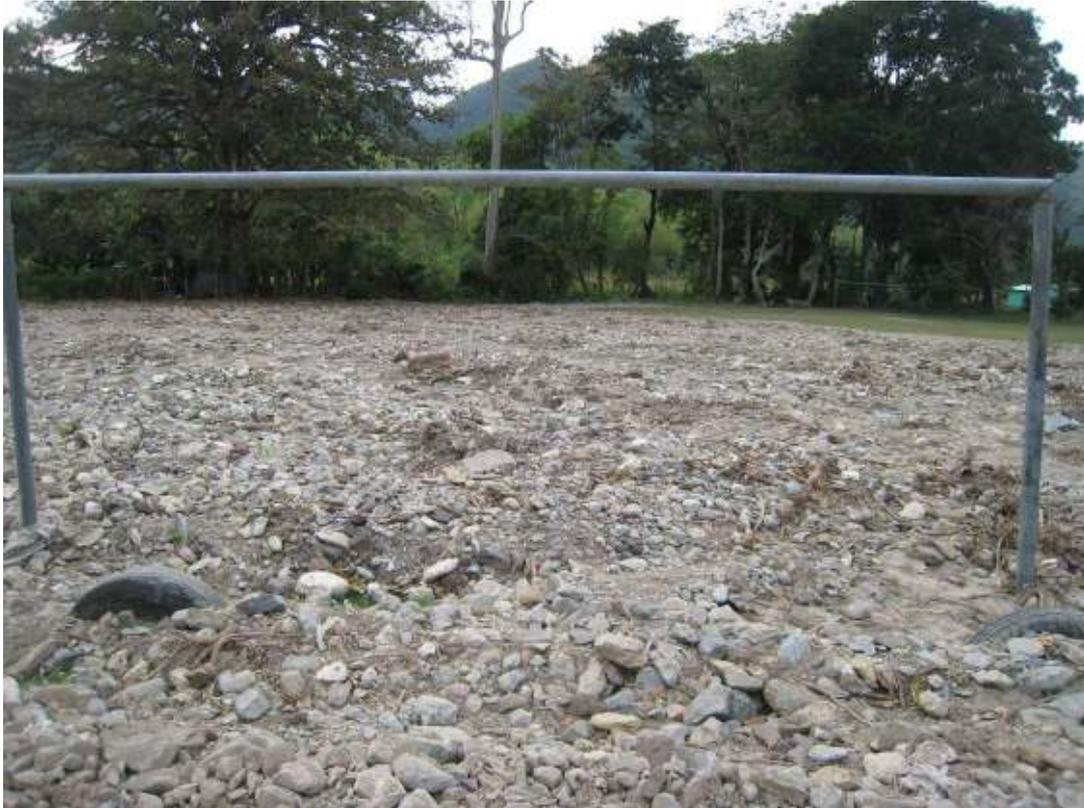
According to the inhabitants in La Union, Department of Olancho, the landslides occurred in the surrounding hills on 21 October 2008. Intense debris flows and mudslides flooded part of the village. The flows passed nearby some houses, damaging one. Fluvial erosion also caused deep trenches in the streets and the soil. The main drinking water pipe broke, and the village lost its water supply for two weeks.

Figure 9. La Union, Olancho. Debris flow deposits cover the former football ground.

During Hurricane Mitch there were some minor landslides in the surrounding areas, but they never affected the village. Since Mitch, many of the surrounding hills have been deforested.

More extensive site investigations are recommended in La Union. The investigations should comprise a hydrological survey and an investigation into the possibility of reducing or diverting the transport of debris. The results would constitute basic data for decision making on structural risk mitigation measures such as altered drainage and the possibility to construct dams and channels to trap sediment/debris and divert overflows. Due to the current situation of heavy rainfall and subsequent risk of inundation of debris flows, it is necessary to address the need of relocating some of the people in the village to safer grounds.

In addition, a number of non-technical measures are recommended, including the development of hazard maps, enforcement of land use regulations, the development of a monitoring network (with rainfall forecasting models), and the establishment of a contingency plan and an early warning system.

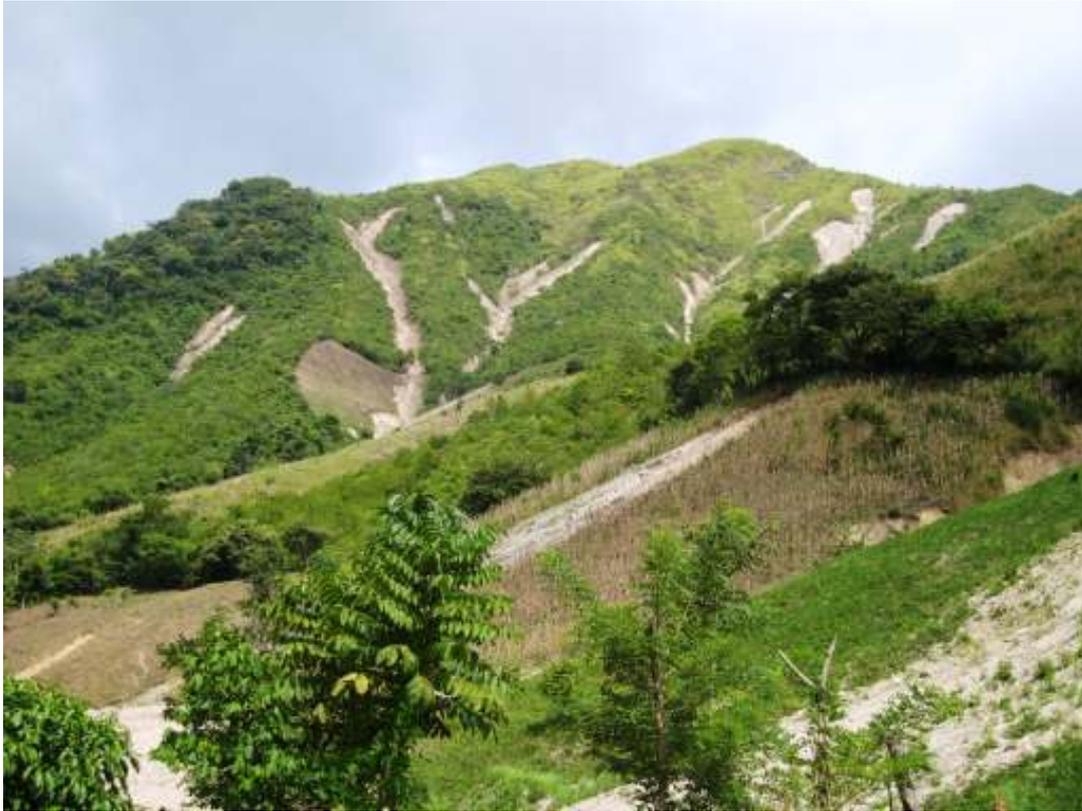
On 20 October 2008, the small village of La Jagua, Department of Olancho, was affected by debris flows and mudflows. According to inhabitants, a total of 50 landslides were triggered in the surrounding hills, killing one girl. The village was subsequently evacuated.

Figure 10. The hills upstream from La Jagua are affected by shallow landslides.

Being situated in a narrow valley surrounded by steep landslide-prone slopes and a river that might overflow, the village of La Jagua is vulnerable to landslides and flooding. The removal of the topsoil layer, caused by erosion in some of the surrounding hills, is likely to increase this vulnerability. Loss of ground cover can also lead to flash flooding.

Based on the risk of being inundated by debris flows, coinciding with heavy rainfalls, it is recommended that the people of La Jagua village, which consists of five houses, are relocated to safer grounds. The selected area for relocation should be based on detailed site investigation of future landslide risk and risk of being inundated by future debris flows in the area.

In order to reduce further erosion of ground cover and avoid flash flooding, replanting of the areas and slopes damaged by landslides with appropriate vegetation should be considered. Reforestation efforts should also be considered as a long-term mitigation measure, as deforestation of the hills might be a landslide-promoting factor.

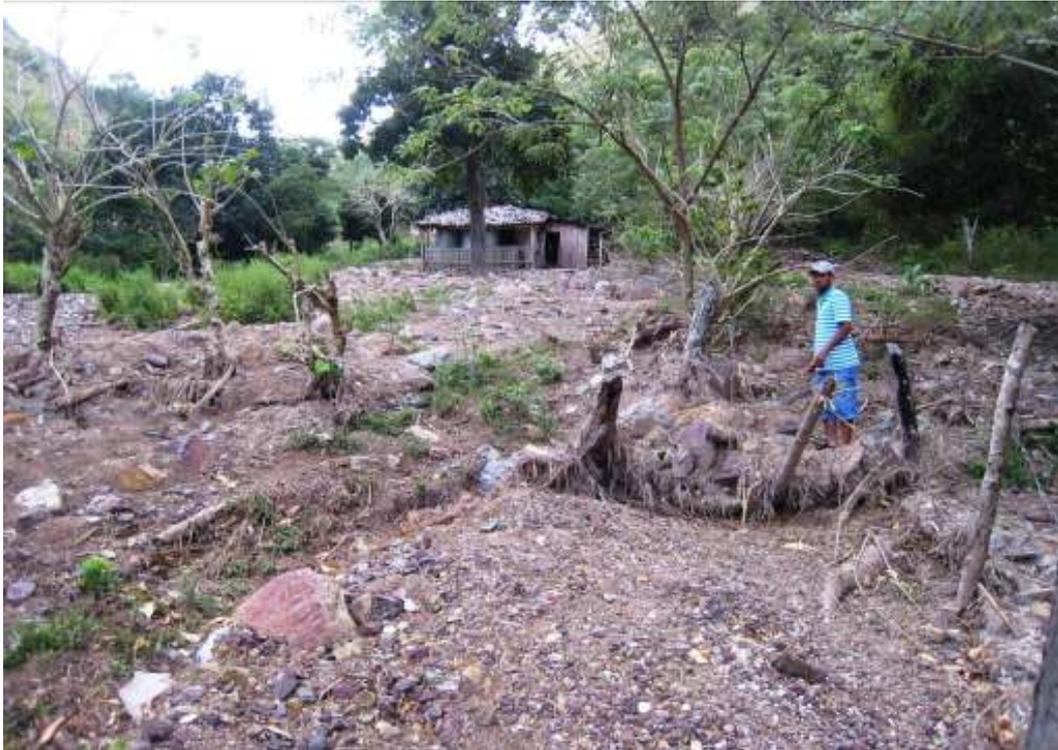
The small village of El Naranjo, in the Department of Olanco, was on 19 and 20 October 2008 partly inundated by debris. In addition, fluvial erosion also caused severe damage to houses and the ground.

Figure 11. Debris flow affected most of El Naranjo village.

The village of El Naranjo is vulnerably situated in a narrow valley, surrounded by steep landslide-prone slopes and a river that might overflow. The landslides on 19 and 20 October 2008, which caused the removal of the topsoil layer, are likely to have increased this vulnerability.

The preliminary recommendation for El Naranjo is to relocate its inhabitants due to the potential risk of being inundated by future debris flows. The selected area for relocation should be based on a detailed site investigation of future landslide risk and the risk of being inundated by future debris flows in the area. The detailed studies in El Naranjo and the immediate surroundings studies should comprise a hydrological study and an investigation of the possibility to reduce transport of debris.

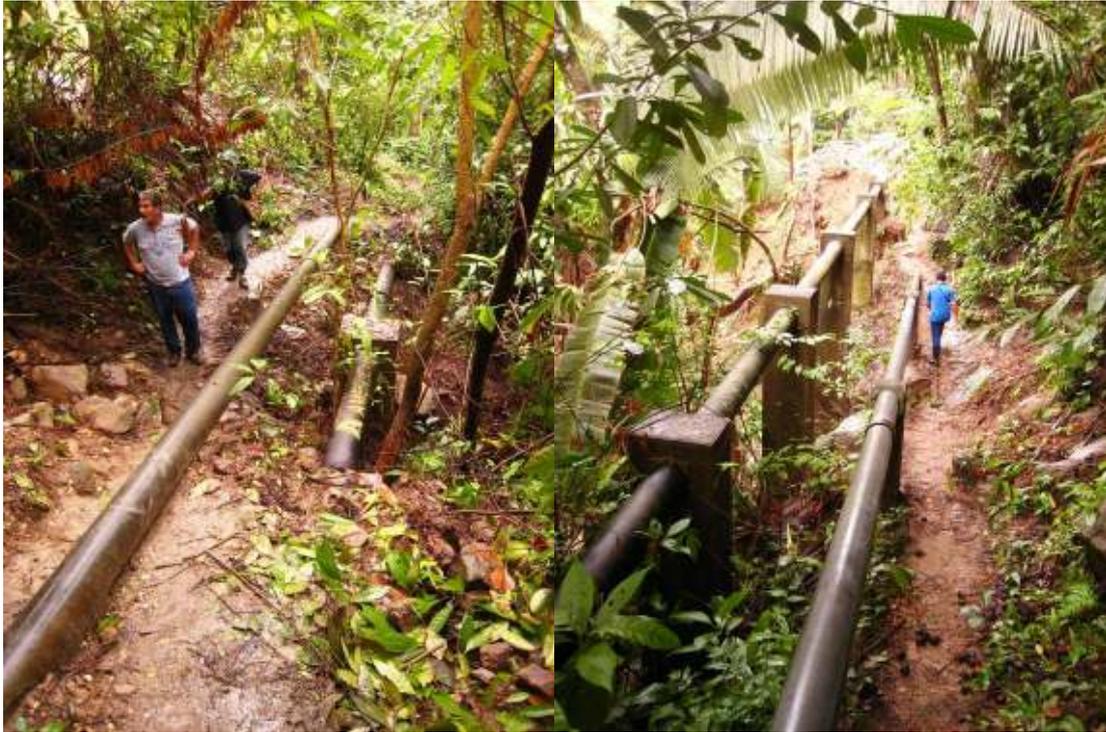
In a landslide in La Presa, Department of Colon, on 20 October 2008, a woman and two children were killed and two water pipes damaged. The city of Sonaguera, which has 20.000 inhabitants, suffered the loss of its water supply, further exacerbating the humanitarian crisis.

The water pipes are located downstream from steep landslide-prone slopes and in the direction of a possible landslide movement of large boulders and debris, and continue to be at risk of being affected again in the future.

Figure 12. The water pipes are located in parallel along the eastern riverbank of Rio Juan Lazaro.

To prevent similar events in the future from happening, three options should be further explored. Firstly, the possibility of relocating the intake of raw water and the water pipes to a safer location should be investigated. Based on the preliminary findings, the most feasible location would be downstream and to the south of the assessed area. Detailed site investigations of water quality and hydrology are essential for the collection of primary data. Secondly the separation of the water pipes by rerouting one of the pipes in order to reduce the risk could be considered. Lastly, it should also be investigated if it is possible to better secure the pipes, by solid construction material and/or by replacing the existing pipes with more flexible material that would be less vulnerable to impacts from future landslides.
