## **GOLD RIDGE TAILINGS STORAGE FACILITY ASSESSMENT**

Solomon Islands

United Nations Disaster Assessment and Coordination

April / May 2014

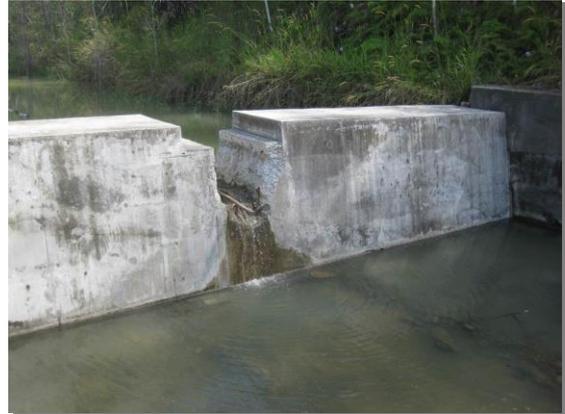
**Photo 1.** Modified spillway control section at the Return Water dam

The spillway invert elevation was lowered on November 2013 and then again in January/February 2014 to what was present in April 2014 with an approximate elevation 98.9 mRL. Water was observed flowing over the modified spillway invert v-notch in April 2014, see Photo 1.

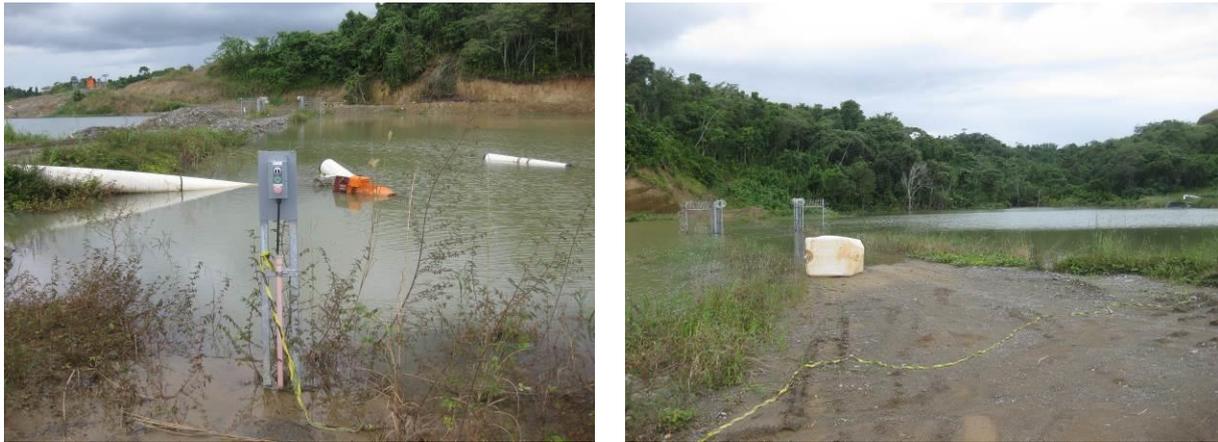
**Photo 2.** Polishing/discharge pond on the left and sedimentation pond on the right

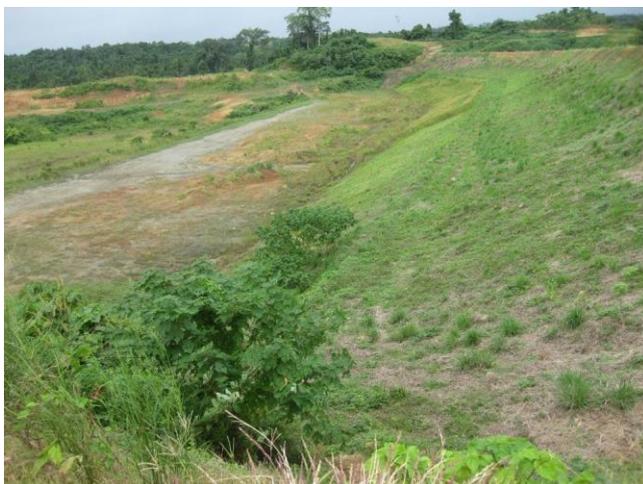
**Photo 3.** View of downstream slope of TSF looking right

and standing water on the crest and downstream bench (40 mRL) was observed. The lower and wider downstream bench had flowing water. No cloudy seepage was observed. The downstream weir was sampled but flow was not measured

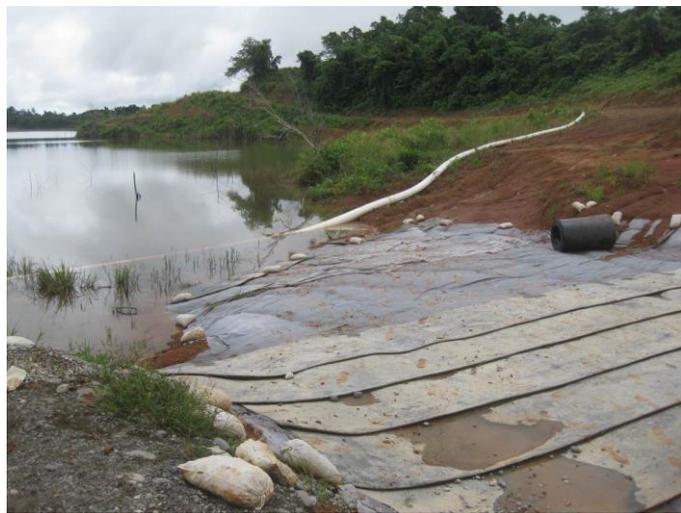
A 21-m long and 10-m wide earth lined spillway channel covered by geotextile and old conveyor belts is located at the left abutment, see Photo 4. The conveyor belts are overlapped and held in place using sand bags, which are likely to shift if water flows over the spillway. The

**Photo 4.** Upstream end of spillway at saddle dam with geotextile and old conveyor belts anchored down using sand bags

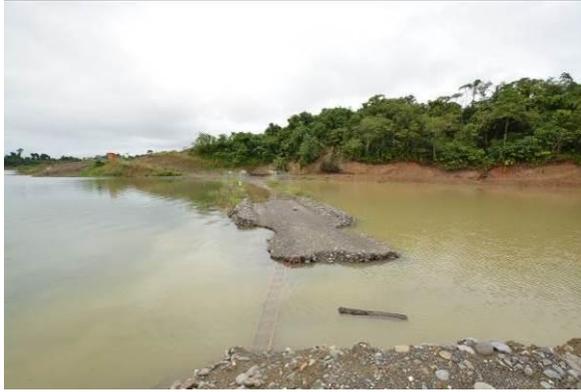
The dewatering was monitored by GRML, who submitted weekly dewatering reports to MECDM, who also produced their own weekly monitoring reports. GRML and MECDM reports from October 2013 – March 2014 show that the plant had experienced some issues during its operation. Water flowing from the TSF into the DP was observed in late October 2013, and in mid-January heavy rains led the SP to overtop into the DP and subsequently into the TSF. Bank erosion between DP and TSF broadened the overflow.

**Photo 5.** TSF (left) has merged with DP (right)

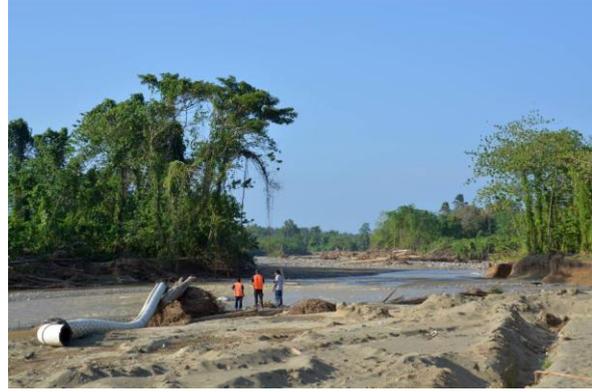
**Photo 6.** Damaged discharge pipe, Tinahulu river

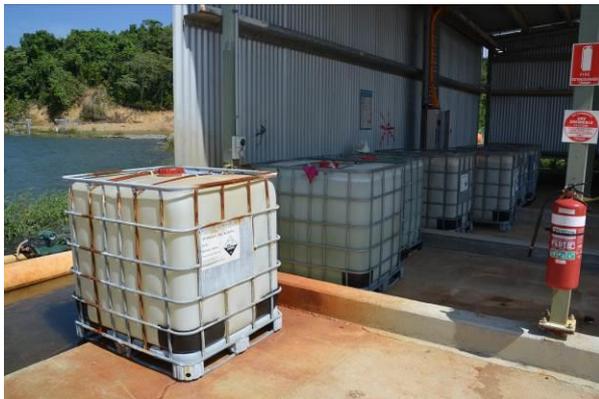
At the water treatment plant, the team observed bulk containers of hydrochloric acid (35%) and corrosive chemicals (Photo 11). At the last site visit, these were within a few centimetres of the TSF water surface level. The Ministry monitoring report from April 11 reports one container to be open and fuming with a photo showing the container to be full. The fuming was likely to be caused by water or water vapour entering the container and causing an exothermic reaction.

**Photo 11.** Chemicals stored next to the TSF

As acid may drip over container edges the container poses a personal safety risk. At the time of the mission visit, the container was already less than half full. The leak could be a cause of the lower pH levels measured close to the WTP.

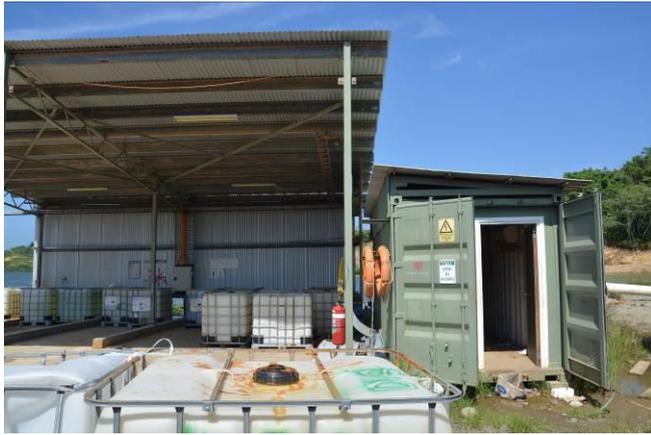
**Photo 12.** WTP Control Room broken into, right hand side

At the last site visit on May 6, it was observed that the control room of the WTP had been broken into (Photo 2-13), and that the electrical equipment had been tampered with (Photo 2-14). These had still been intact at the team's first site visits. The WTP stood unguarded and the longer it remains so the higher the risk that it will be vandalized and key parts, wiring and equipment stolen. The chemical containers pose a hazard to locals accessing the site. Despite the fact that the containers are sealed and marked, they could be damaged causing harm to humans and the environment – in addition to lowering the pH of the TSF water. Police guarding the GRML facility were briefed on the acuteness of the situation by the team and GRML national employees.

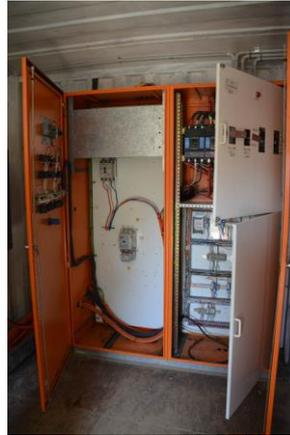
**Photo 13.** WTP Electrical cabinets opened, level of damage unclear

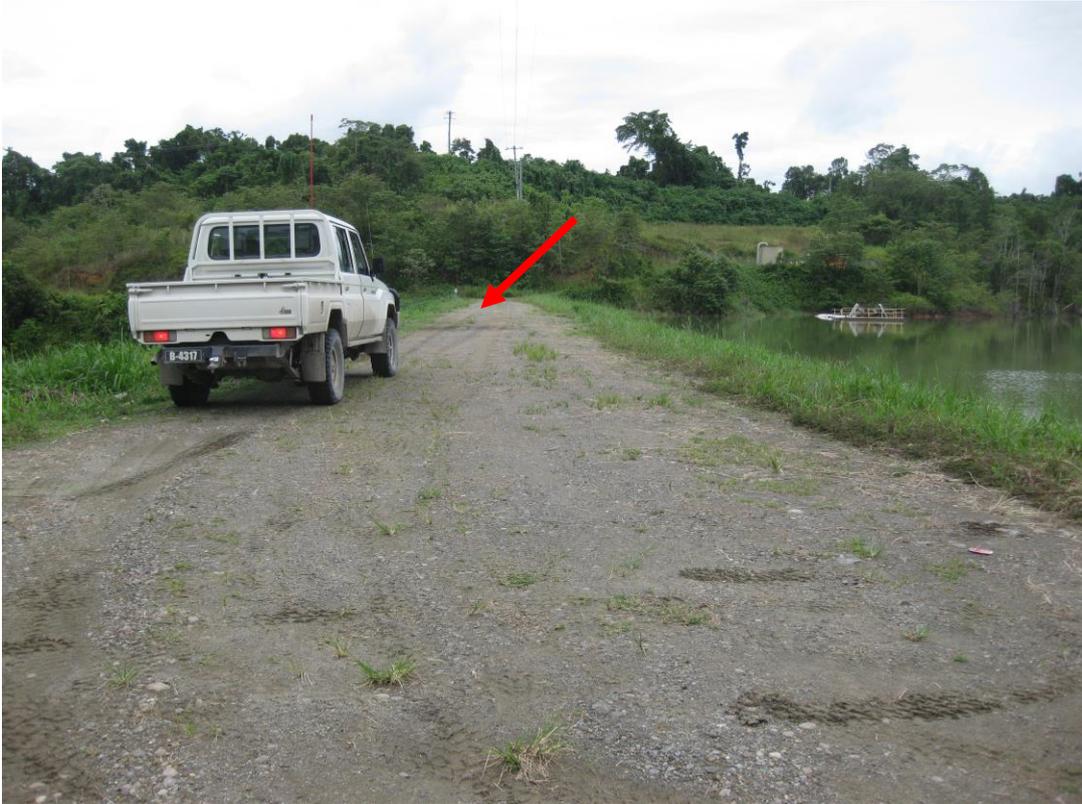
3. Crest of Return Water dam, looking right. Localized crest settlement was observed as shown by arrow.

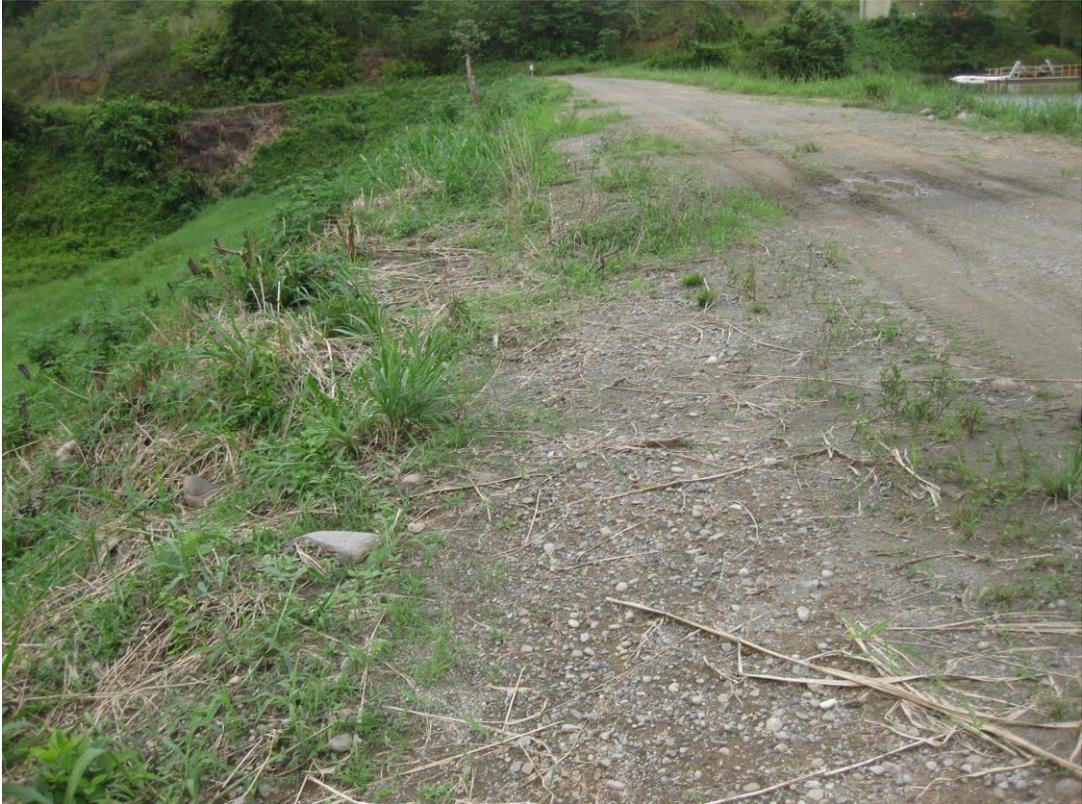
4. A close-up view of area shown by arrow in Photo 3 indicating localized crest settlement at the Return Water dam.

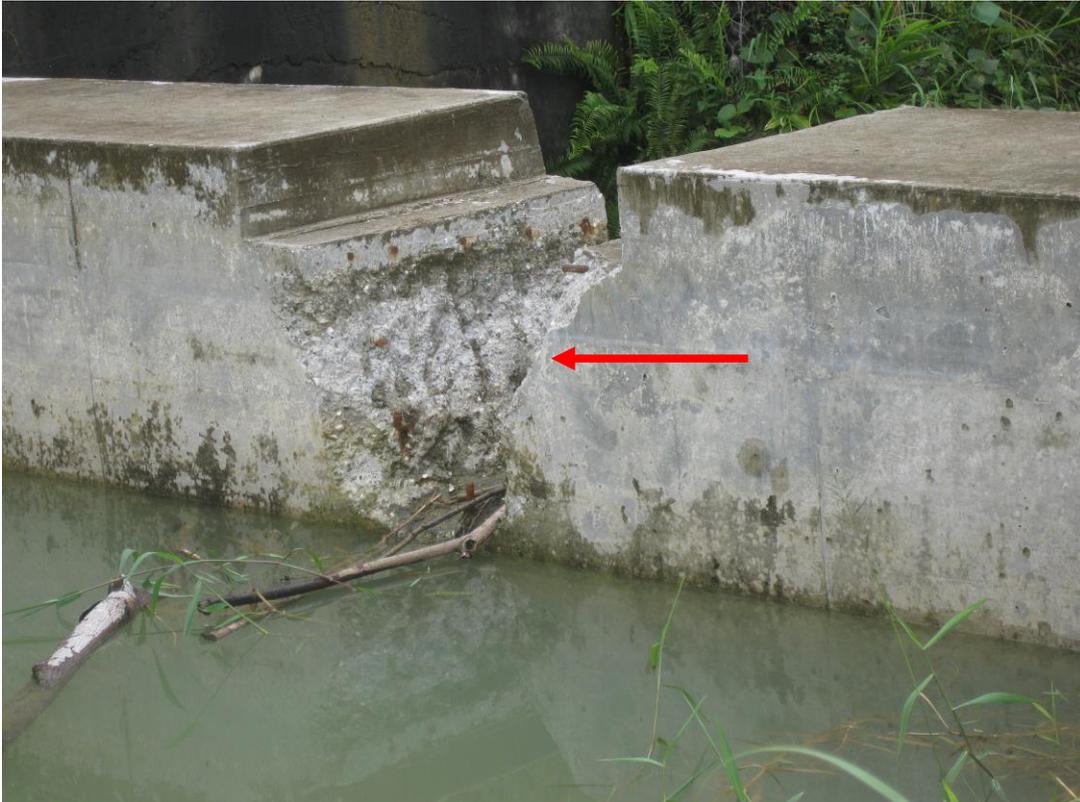
5. Return Water dam spill way crest, looking upstream. Arrow show lowered spillway invert notch elevation. Original design has no concrete block. Observed freeboard was approximately 100 mm on April 25, 2014.

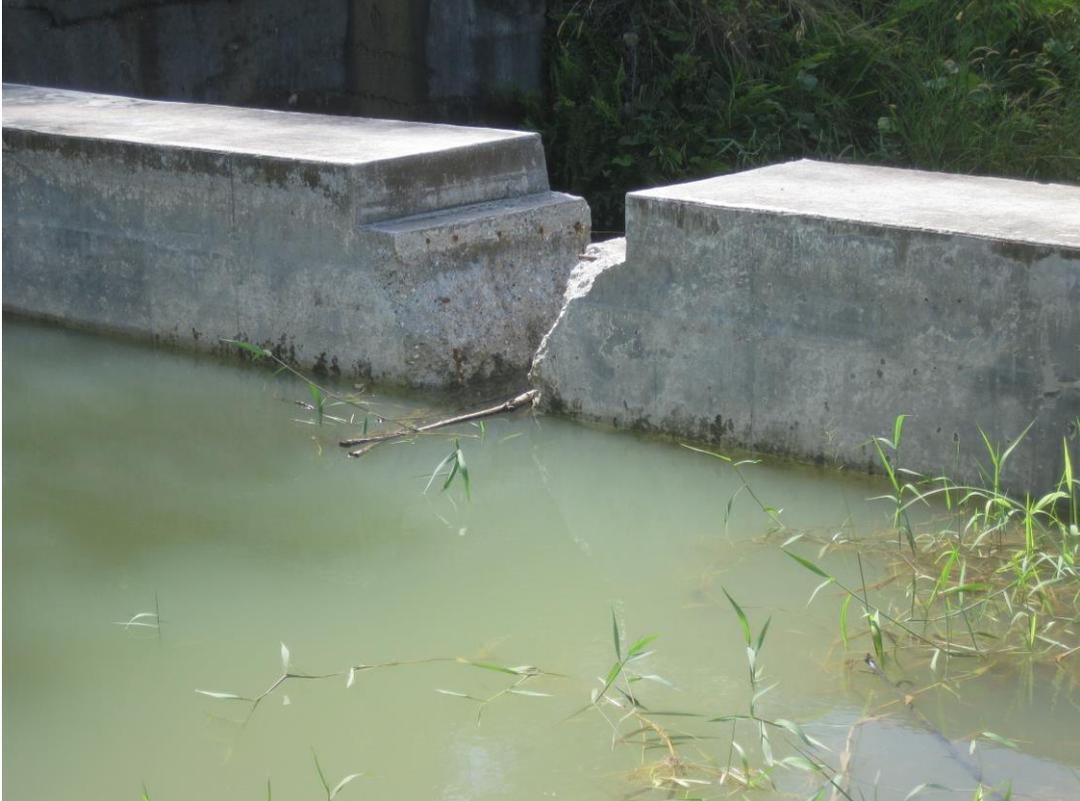
6. Return Water dam spill way crest, looking downstream. The spillway was operating with a flow of approximately 20 mm on April 26, 2014 and 50 mm on April 29, 2014.

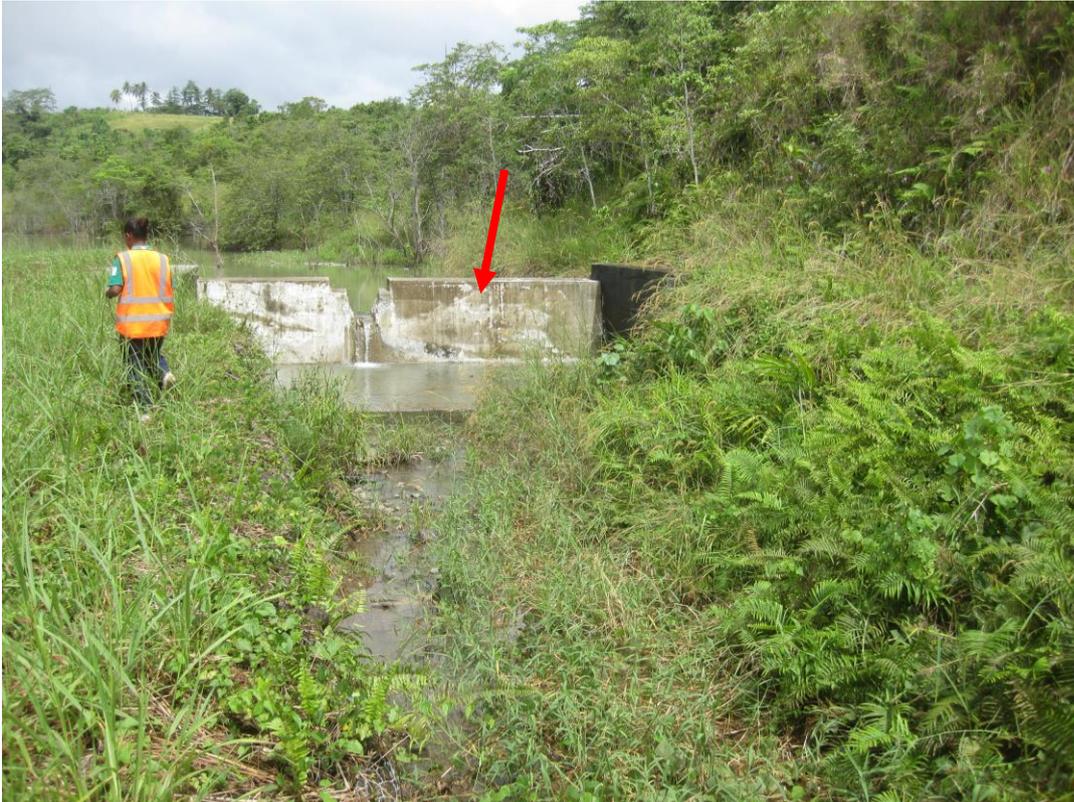
7. Spillway channel looking upstream. Arrow show concrete block modification which should be removed to provide adequate freeboard for the dam.

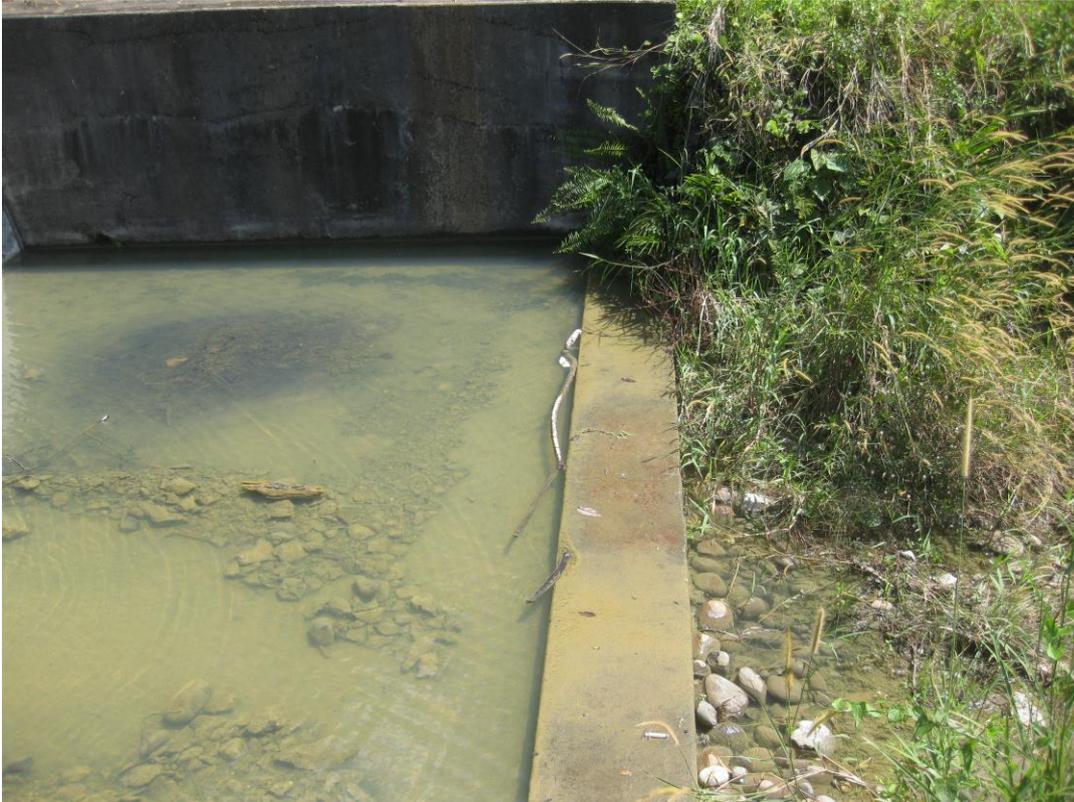
8. Control section at downstream end of stilling basin at Return Water dam spillway, looking left. Note minor debris in the basin.

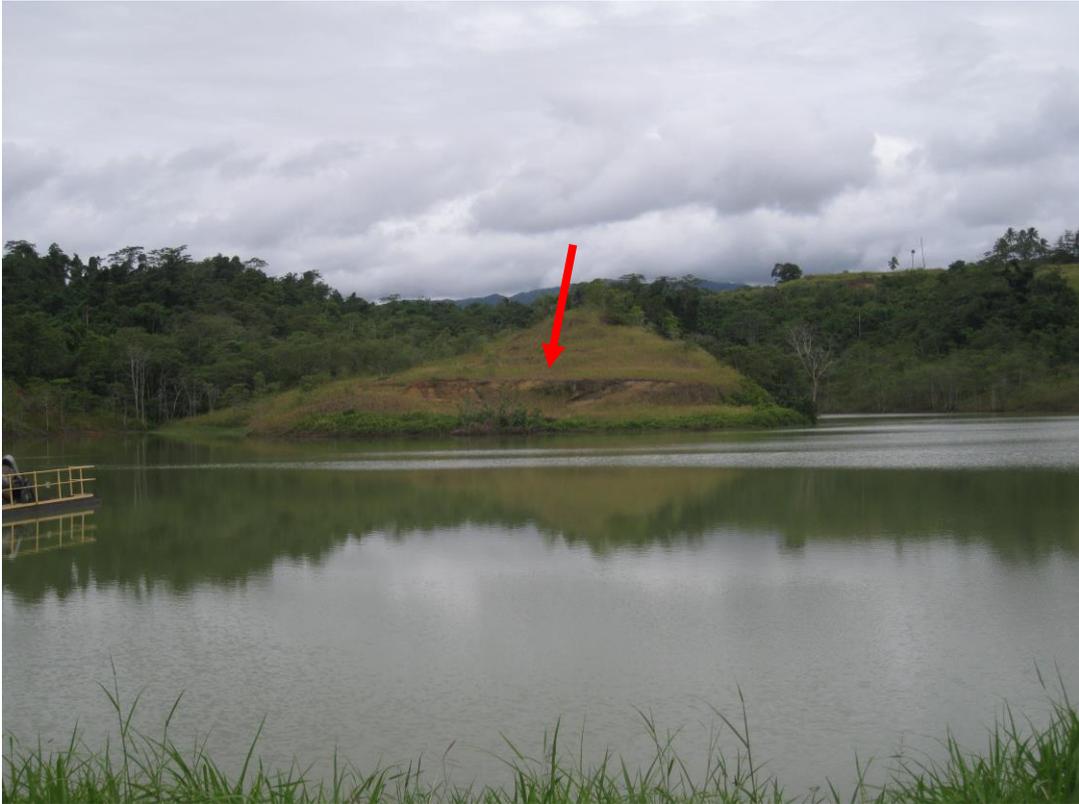
9. Arrow shows instability of reservoir rim at the Return Water dam, looking upstream.

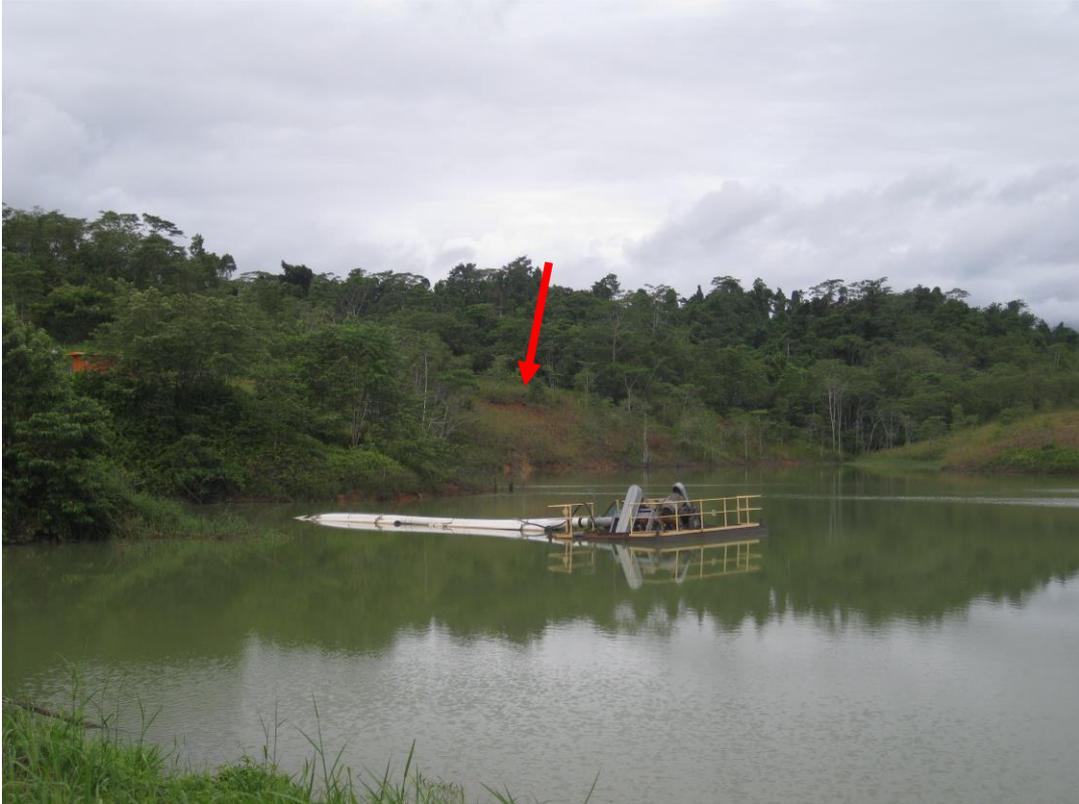
10. Arrow shows instability of reservoir rim at the Return Water dam, looking upstream toward the right side.

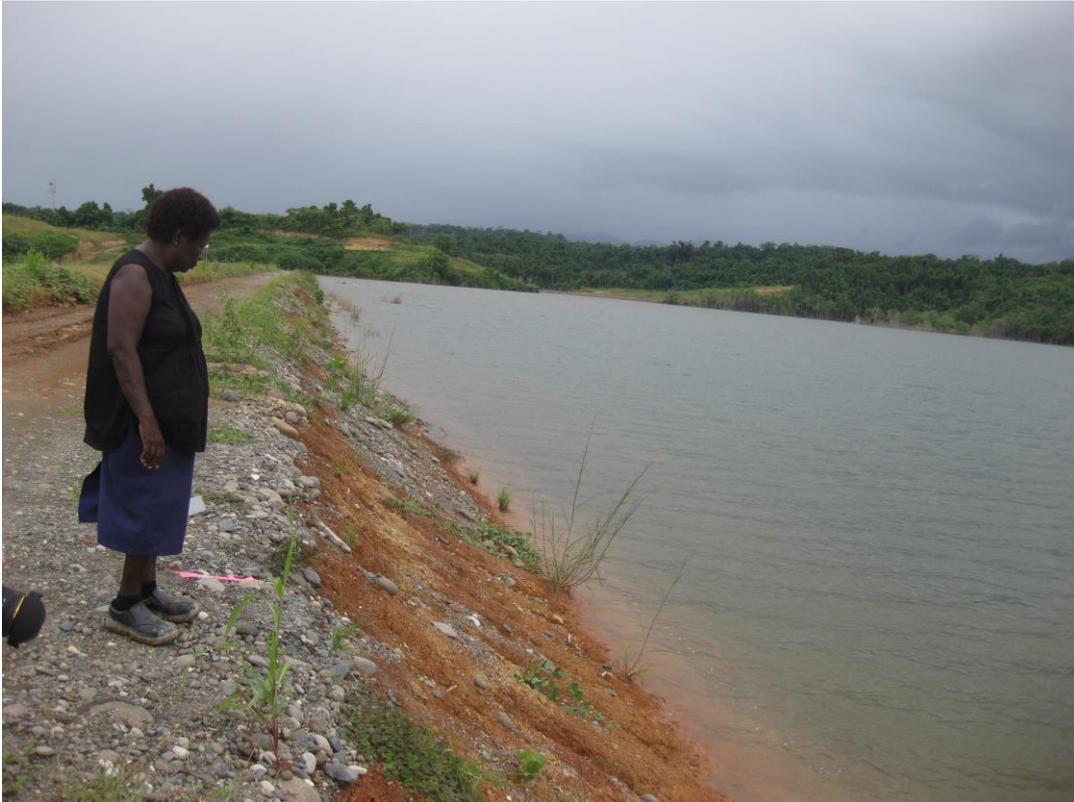
11. Upstream crest of the TSF, looking right. Note erosion of upstream slope and lack of slope protection. Estimated vertical freeboard distance between the TSF crest and the pond water level is approximately 1700 mm.

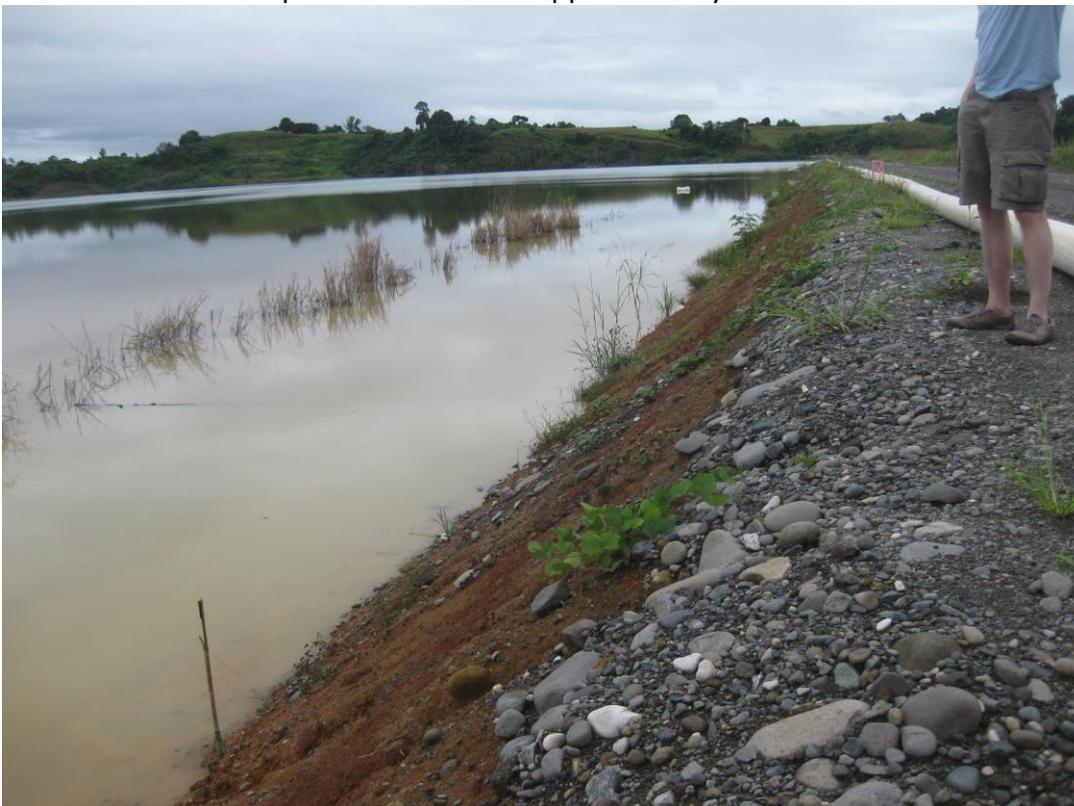
12. Freeboard near the right abutment of the TSF, looking left. Estimated vertical freeboard distance between the TSF crest and the pond water level is approximately 1700 mm.

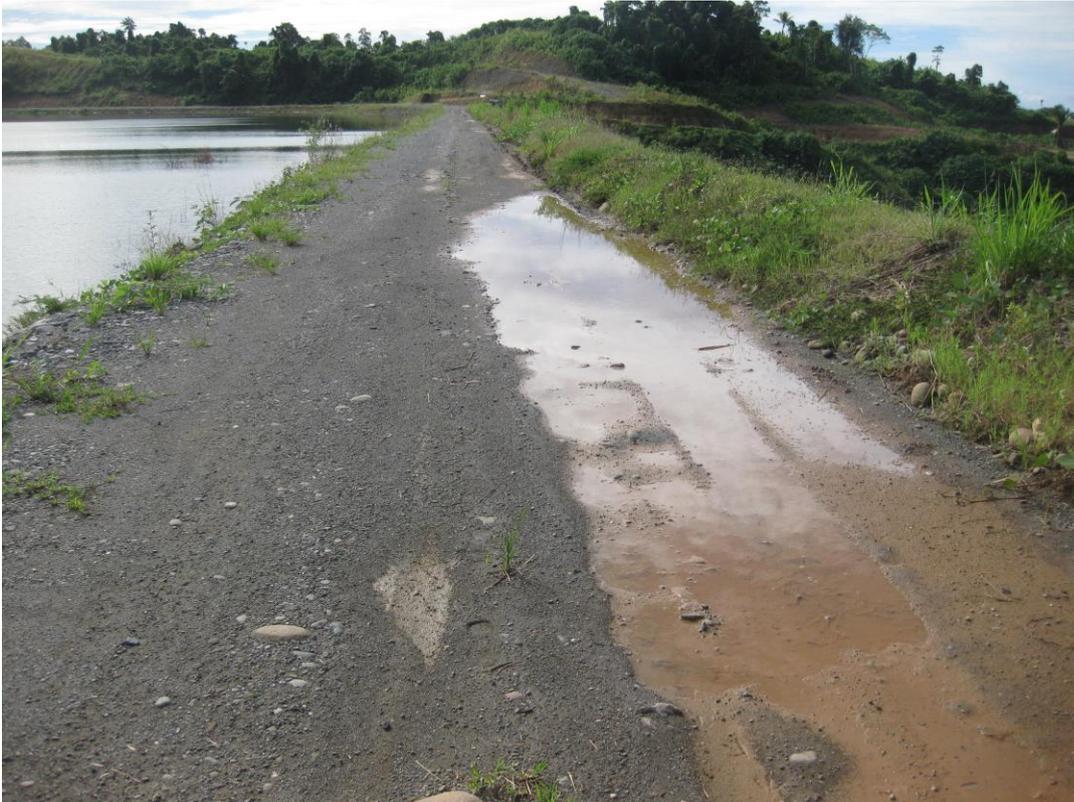
13. Standing water observed on TSF crest after rain event, looking left.

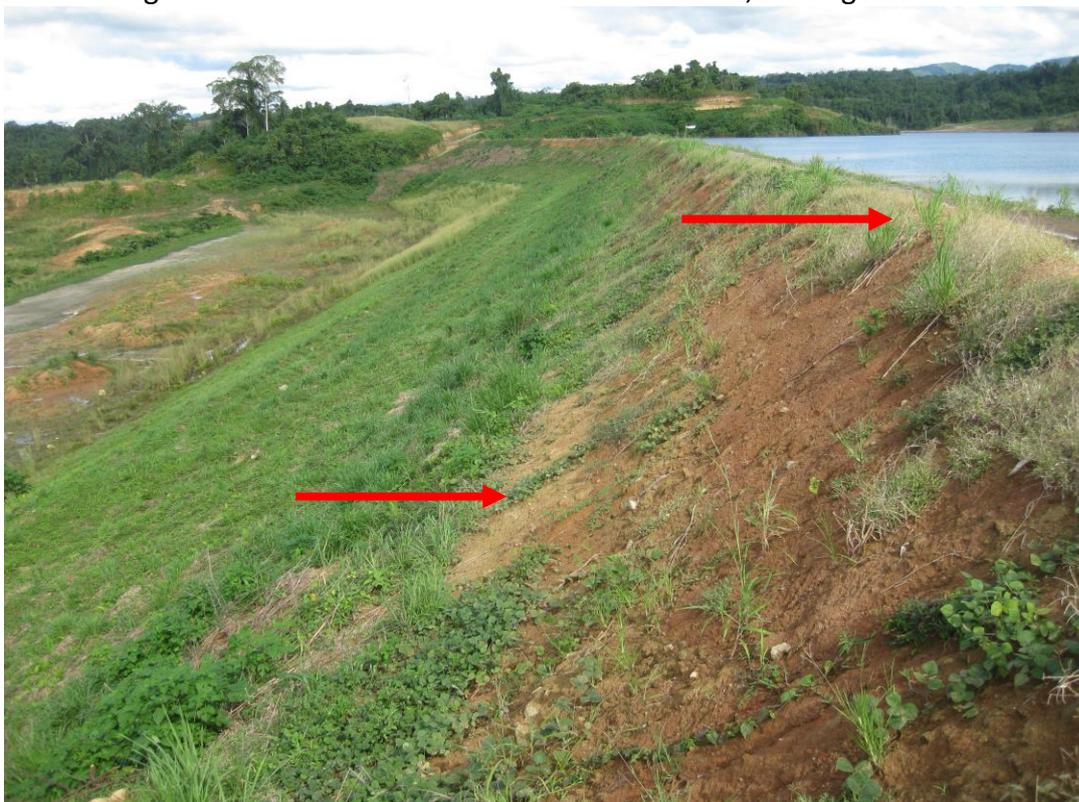
14. Downstream slope of the TSF, looking right. Arrows indicate upper lift that was recently placed with an approximate slope of 1.5H:1V and no downstream filter.

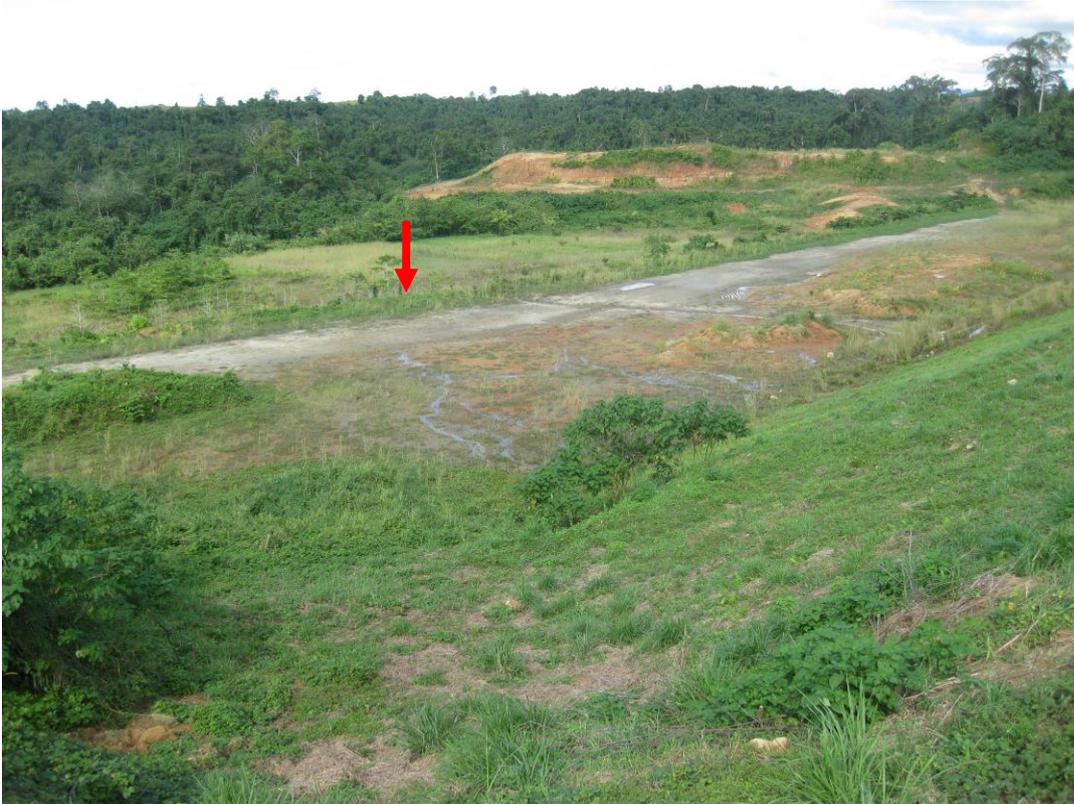
15. View of the downstream toe area with water present near the left abutment. It is not clear if this is from water seeping through the embankment or the abutment. Arrow showing approximate location of standpipe piezometer shown on Photos 17 and 18.

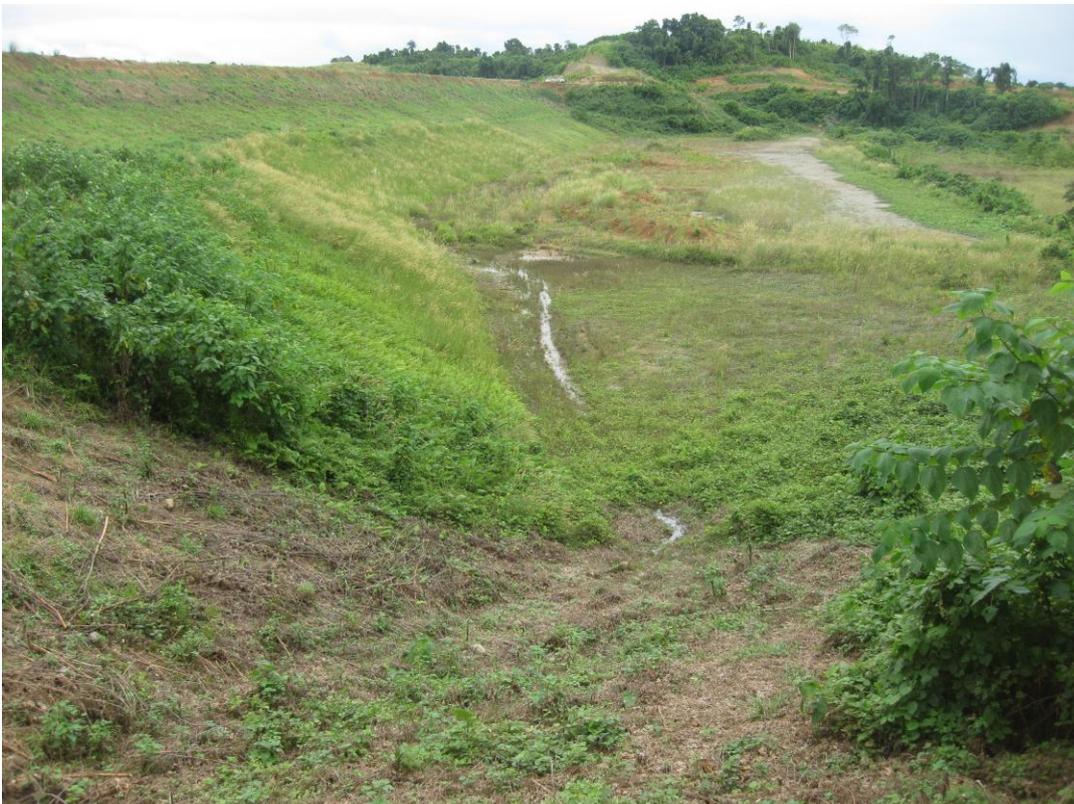
16. Water flowing near the right abutment. It is not clear if this is from water seepage through the embankment or the abutment. No cloudy seepage was observed.

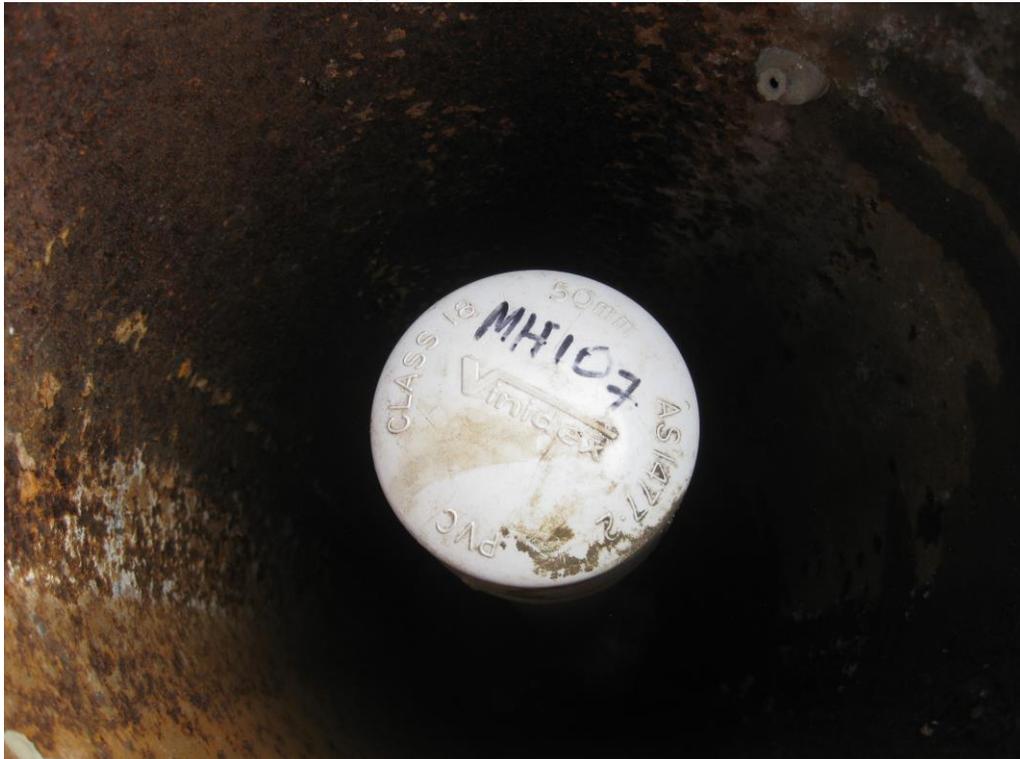
18. Piezometer MH107 installed in 2005 constructed using bell jointed 50 mm ND Class 9 uPVC casing installed to a depth of 19.8 m below ground level with a slotted length of 3 m (Golder, 2005). Water was recorded 5.9 m below the ground surface in October of 2005 (Golder, 2005). Water was not recorded during the April-May 2014 site visits.

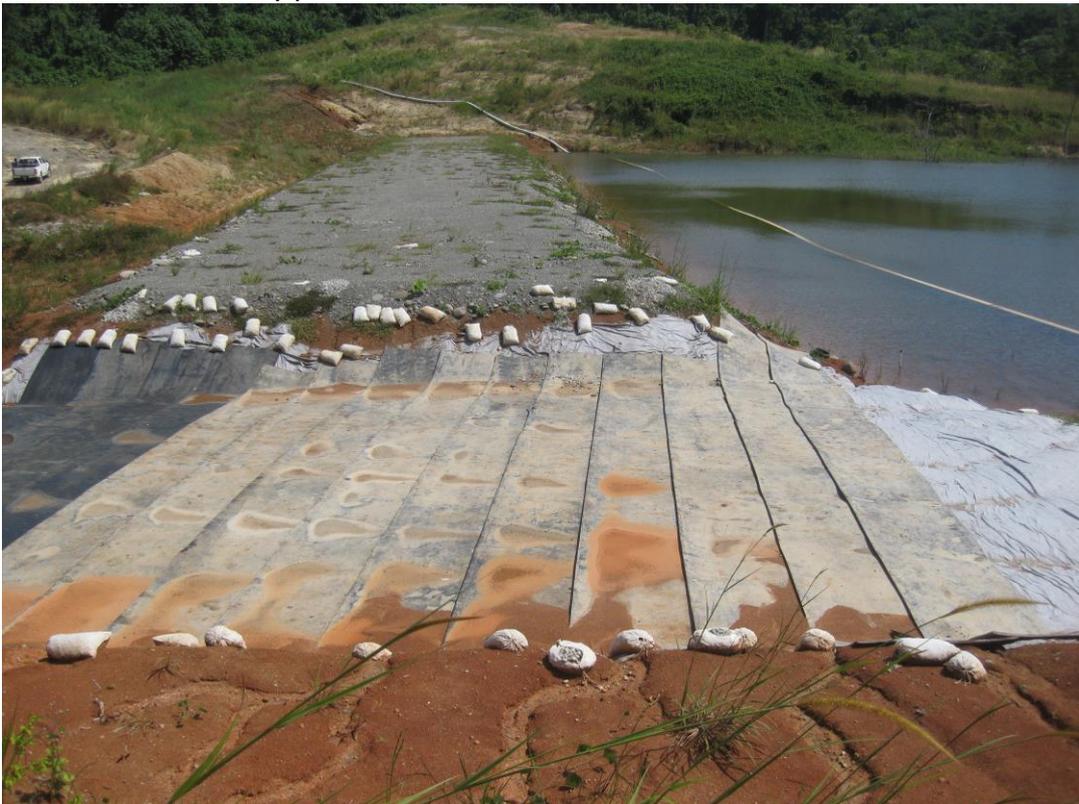
20. Spillway channel with geotextile underlain by old conveyor belts, looking right. Available freeboard is approximately 600 mm.

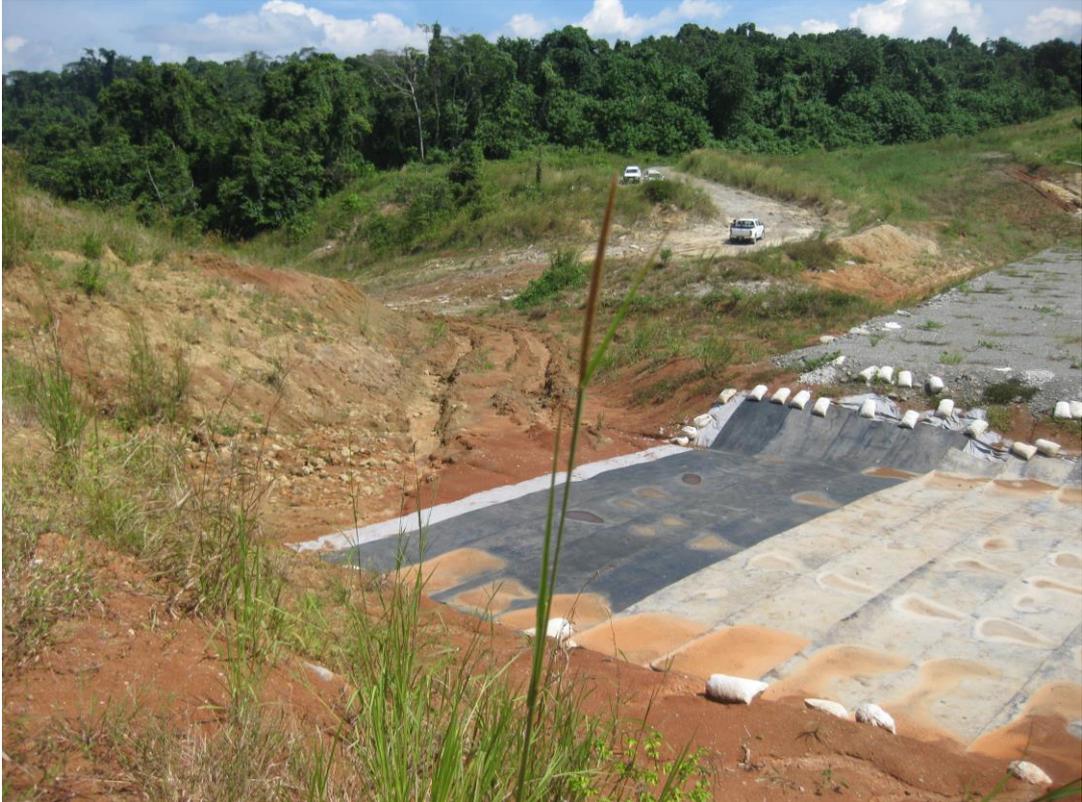
22. Spillway channel at Saddle dam, looking downstream and right. Note erosion in spillway channel due to surface water runoff, also shown on Photo 23.

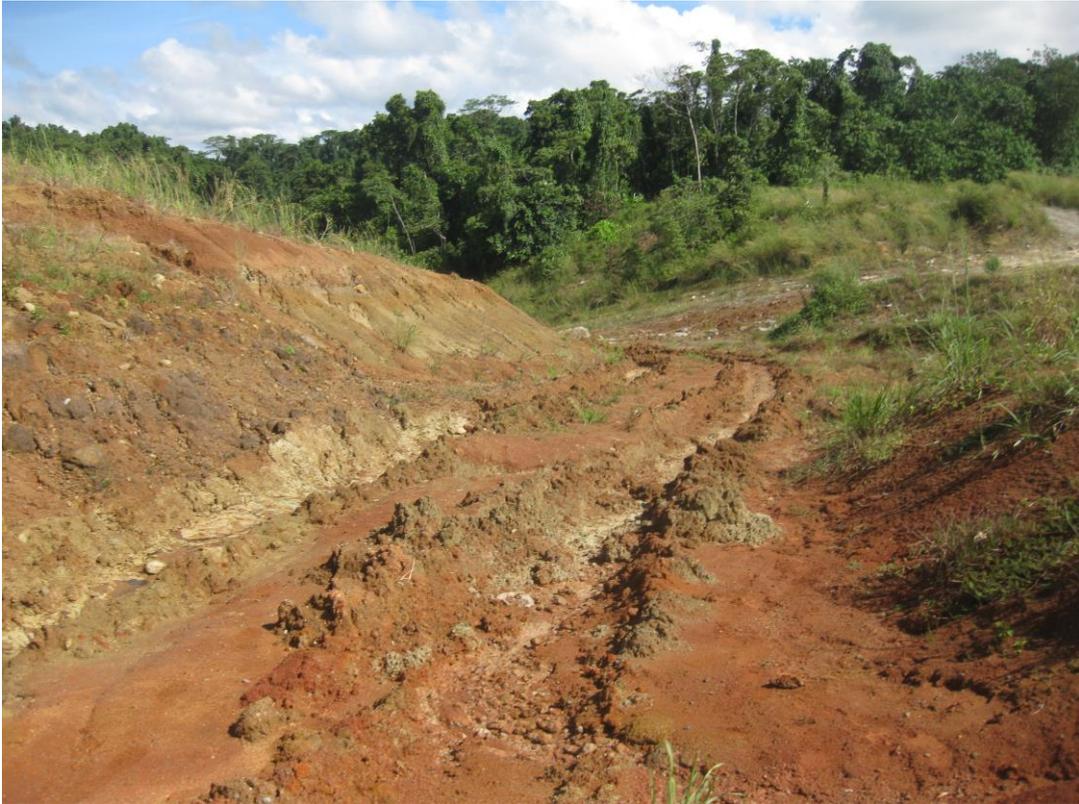
23. Spillway channel, looking downstream beyond spillway section. Note erosion gullies due to surface water runoff.

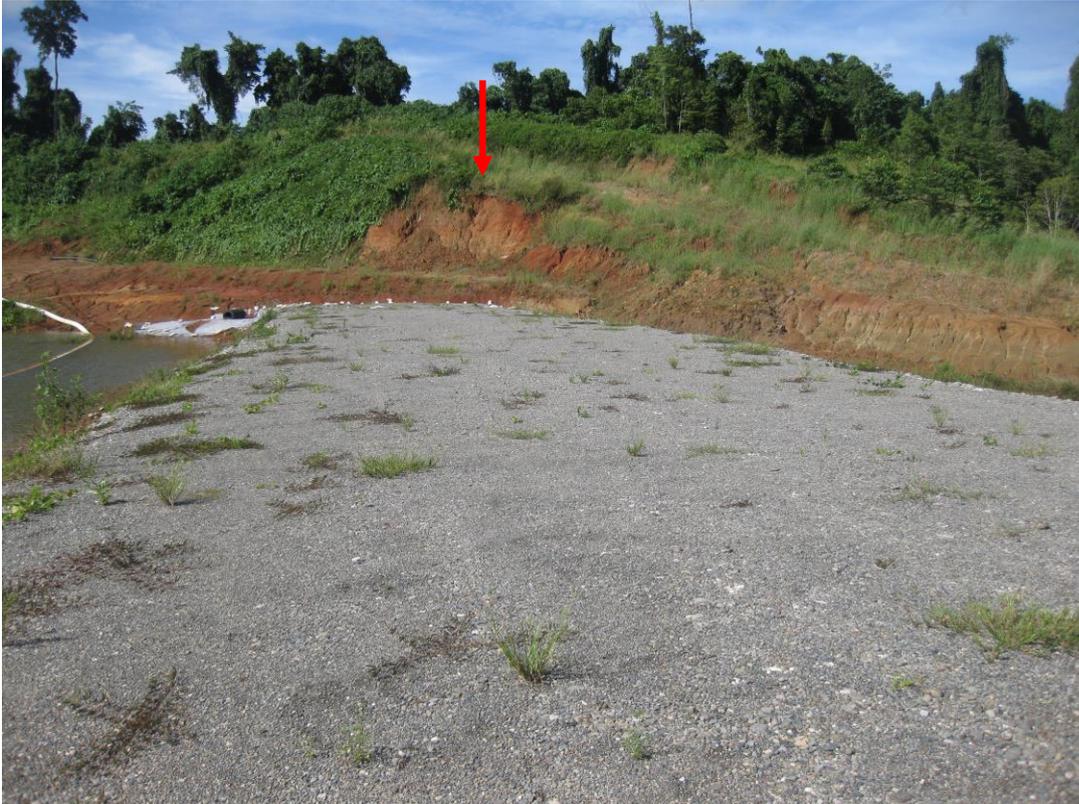
24. Crest of Saddle dam, looking left towards spillway. Arrow indicates recent sloughing of material downstream and left of the spillway, as shown on Photo 25.

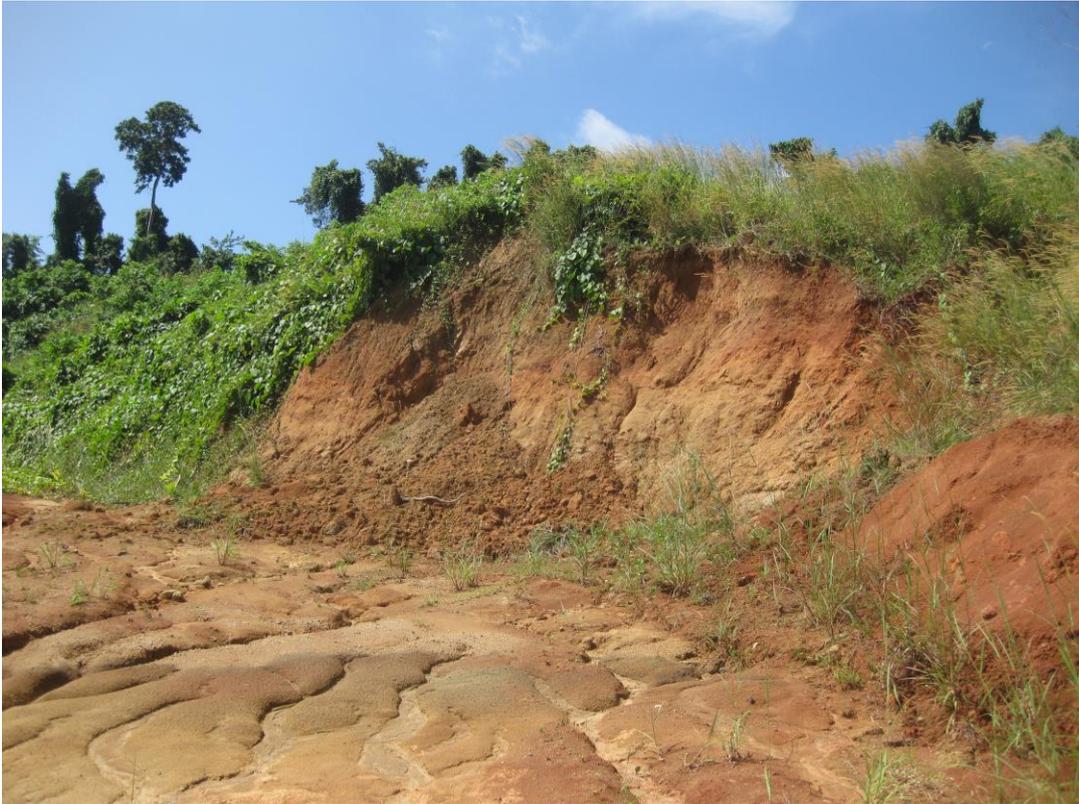
25. Recent sloughing of near vertical cut located downstream and left of the Saddle dam spillway channel.

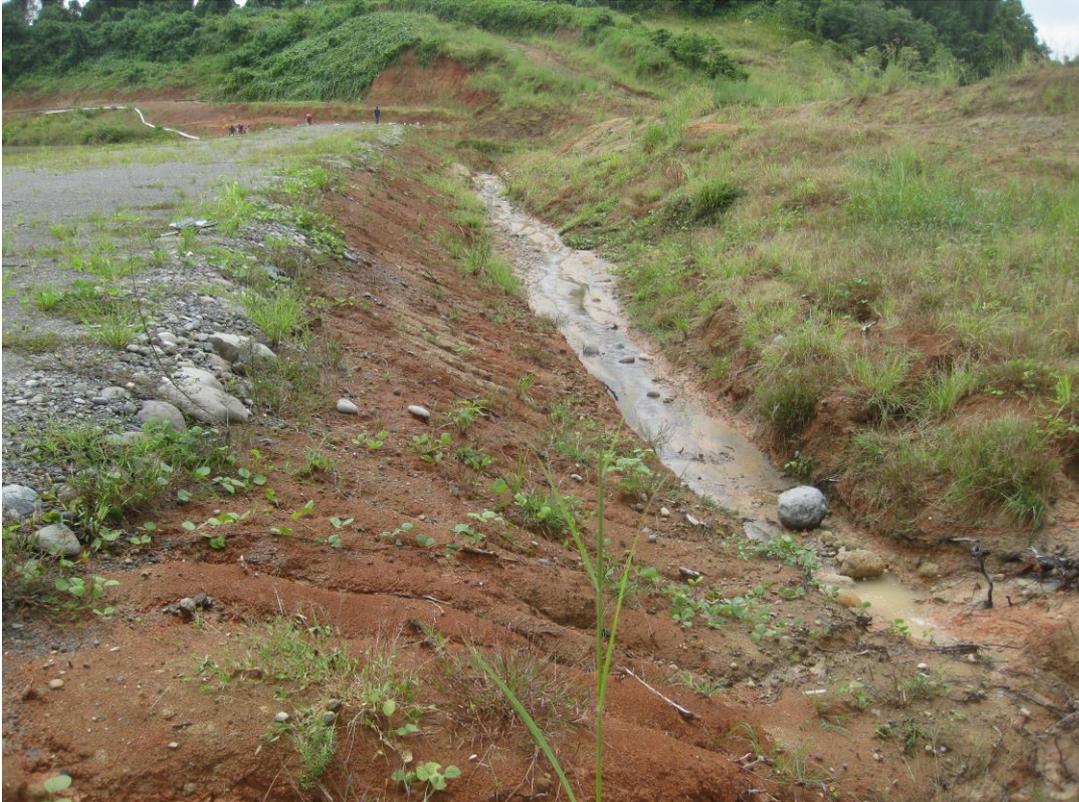
28. Downstream slope of Saddle dam with ditch, looking left. Water in ditch is most likely due to surface water runoff. No water was observed in ditch on the last site visit.
