## **GOLD RIDGE TAILINGS STORAGE FACILITY ASSESSMENT**

Solomon Islands

United Nations Disaster Assessment and Coordination

April / May 2014

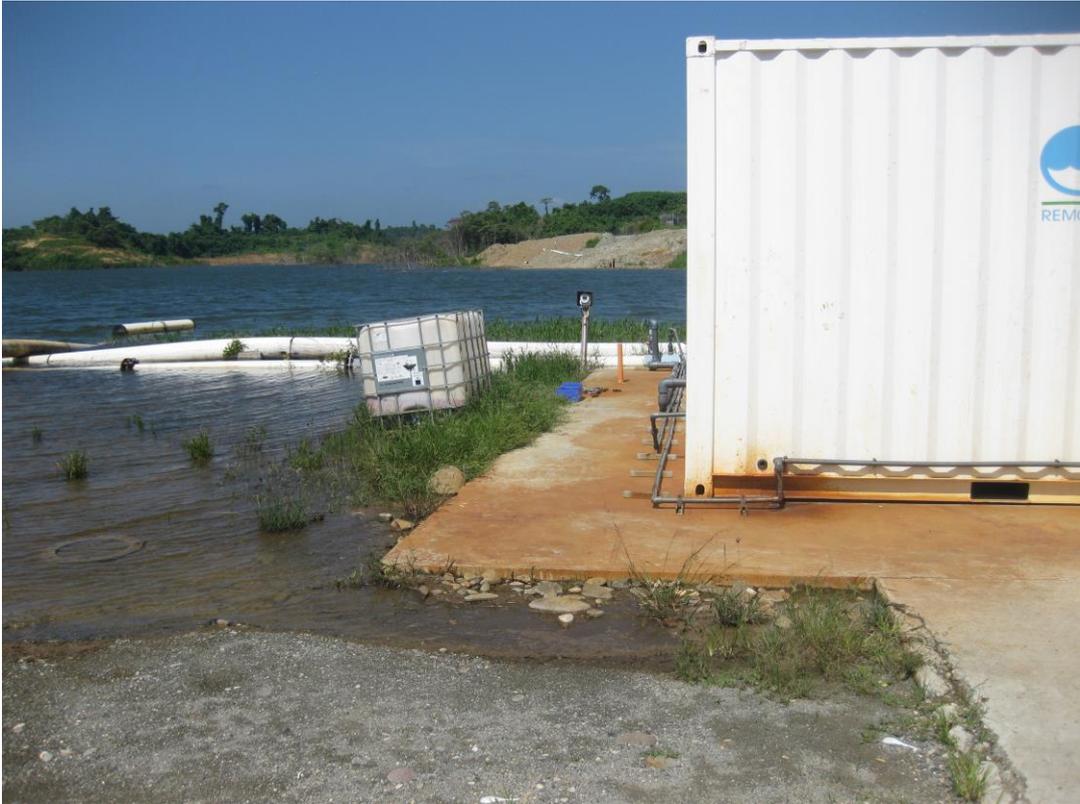
29. Water treatment plant located at upstream edge of TSF pond. Available freeboard distance between pond water level and water treatment foundation concrete pad is approximately 100 mm.

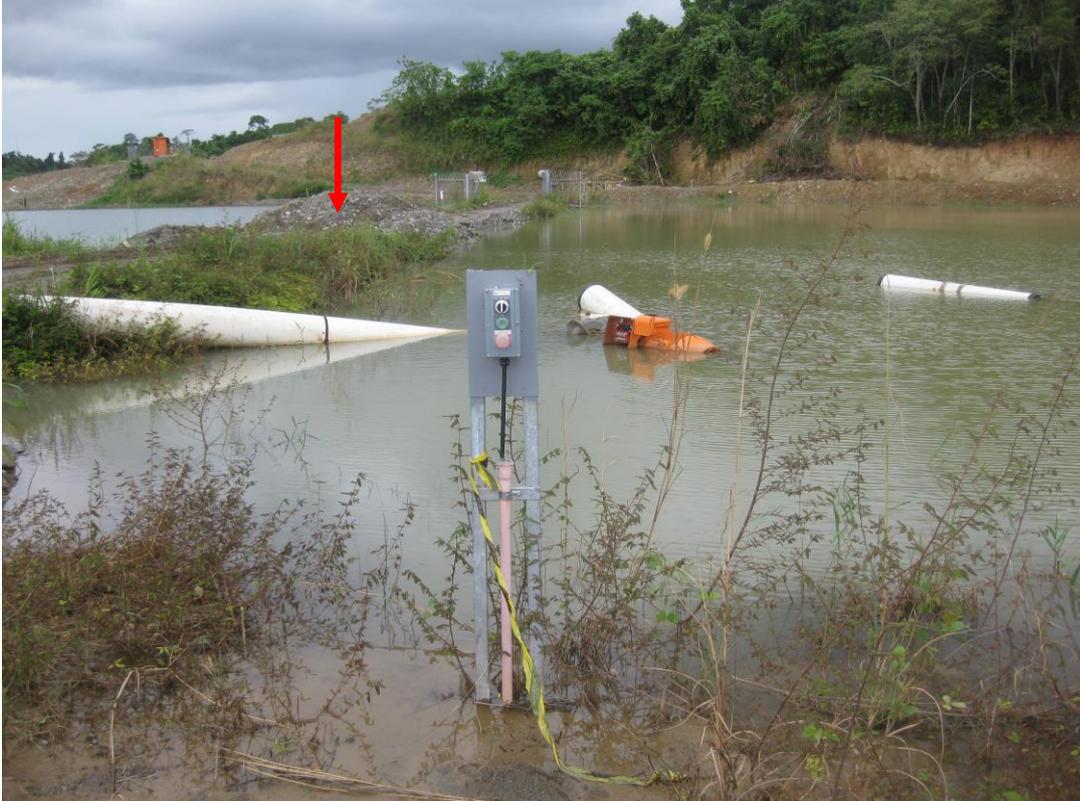
30. Earth embankment between TSF pond and discharge/polishing pond. Arrow shows location of breach shown in close-up view on Photo 31.

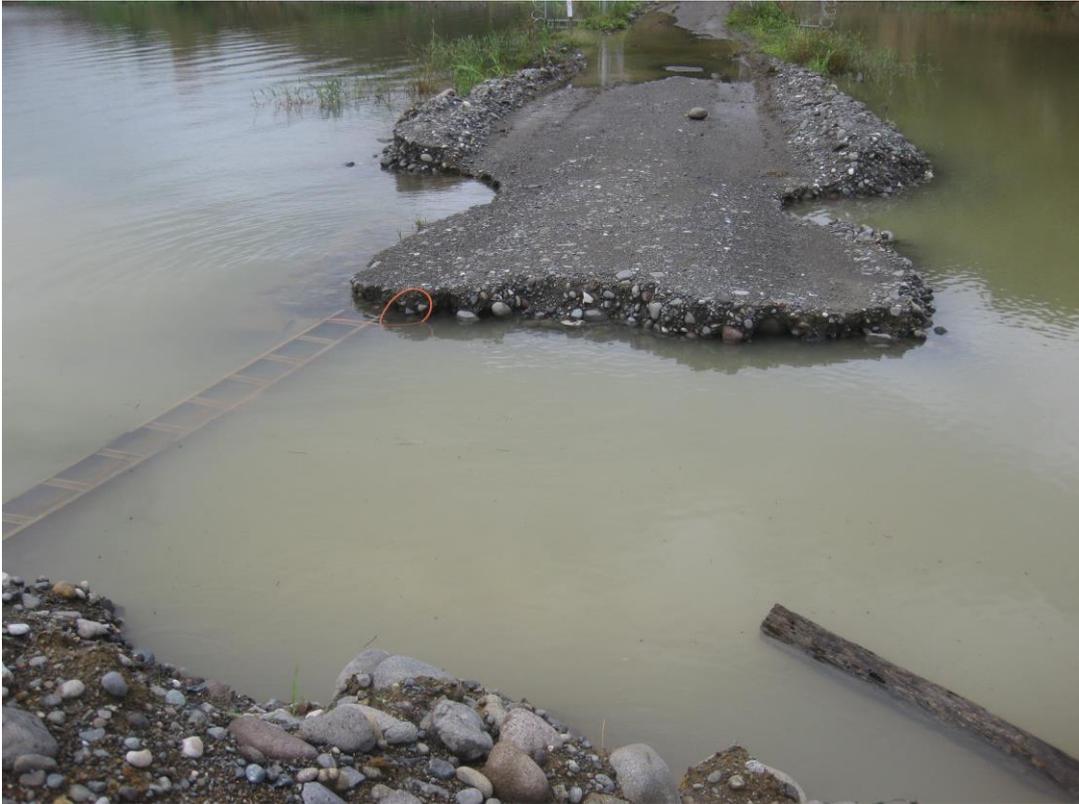
31. Breach of earth embankment between TSF pond (to the left) and discharge/polishing pond (to the right). Note gravelly sand with cobbles used to construct the embankments.

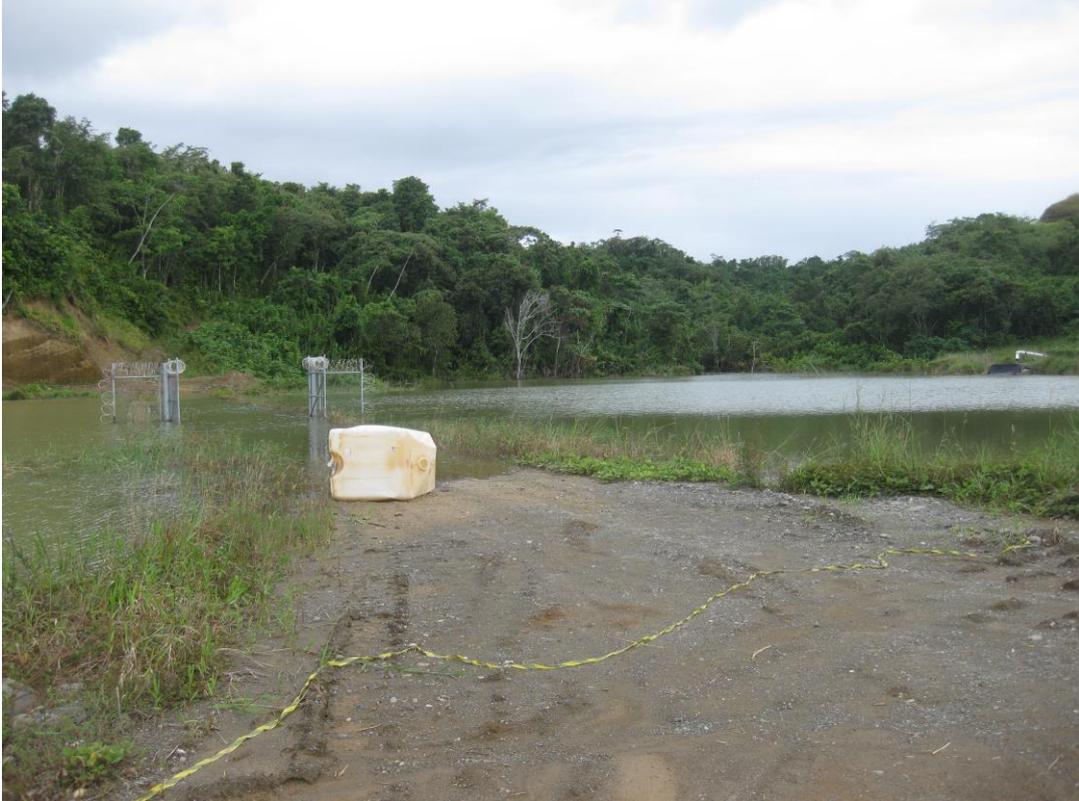
32. Overtopped earth embankment between discharge/polishing pond (to the left) and sedimentation pond (to the right).
