## Environmental Assessment

*Hurricane Ike*  
*Turks and Caicos Islands*  
*8-21 September 2008*

JOINT  
UNEP / OCHA  
ENVIRONMENT UNIT

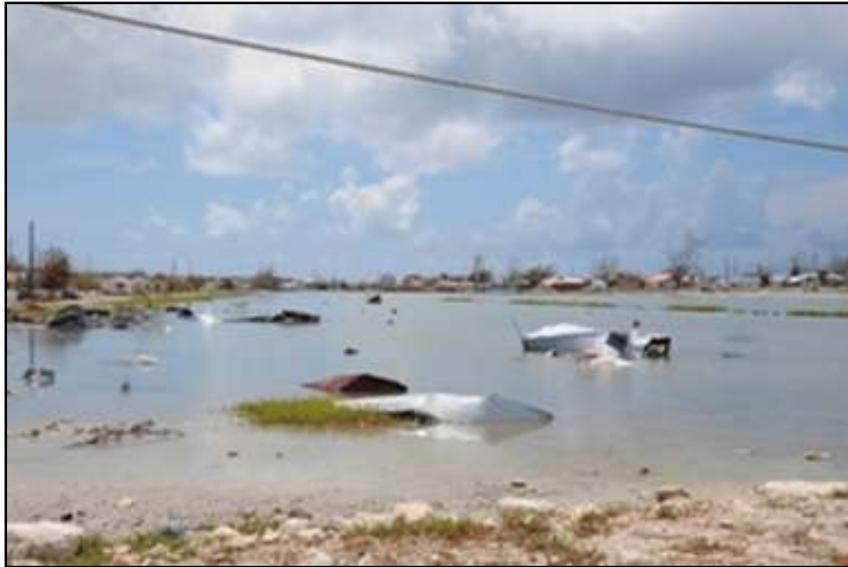
Image: Debris spread over South Creek in Grand Turk (photo: P. Ugarte)

As regards waste classification, there is an urgent need to classify hazardous and non-hazardous waste from collapsed buildings, medical waste, food, etc. It is also necessary to re-organize the dump site and clean-up the hurricane debris spread over salt ponds and creeks.

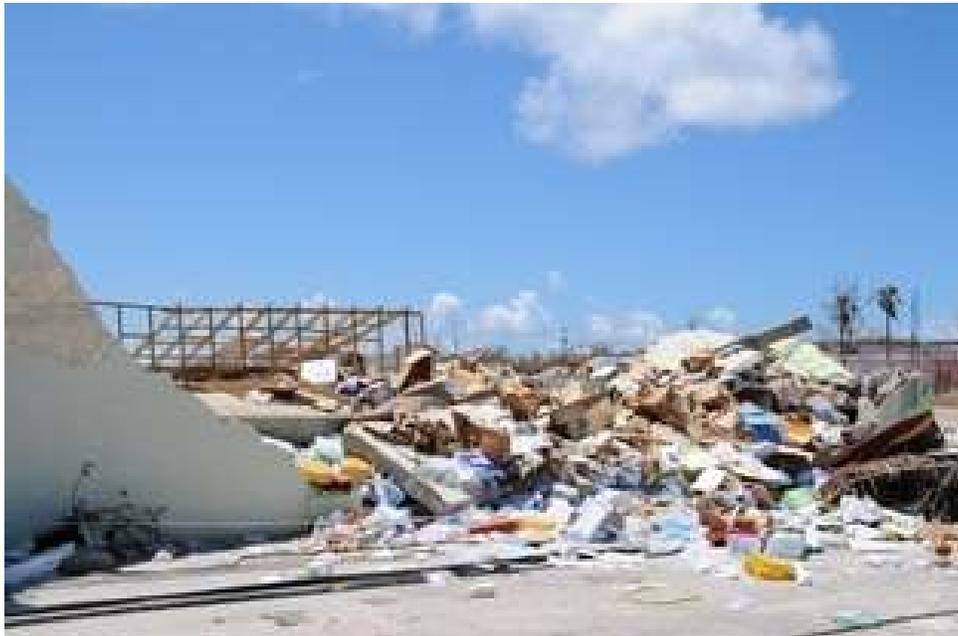
The most visible impact of the hurricane was debris from collapsed infrastructure. Waste management had already been a major problem in Grand Turk before the hurricane season. However, according to the government storms Hanna and Ike aggravated the situation.

Image: Collapse building in Grand Turk (photo: P. Ugarte)

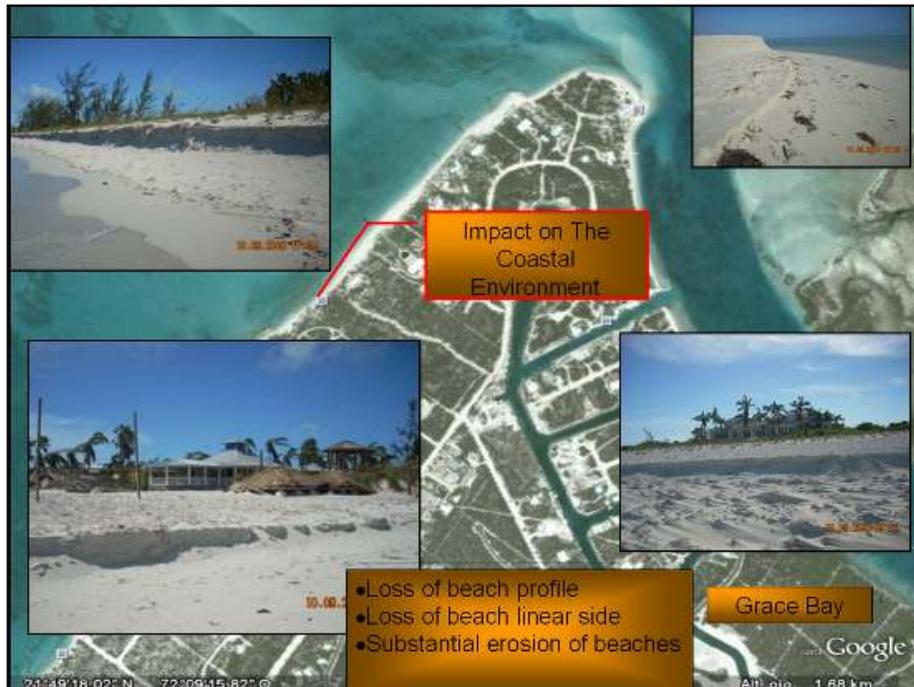
Several beaches such as East Grace Bay suffered substantial erosion, in particular loss of up to five feet sand in height; and loss of linear side of the beach. A restoration project of Emerald Beach completed in June 2008 was completely lost. Monitoring was in process to calculate the losses;

In the sites assessed, mangroves have been damaged. Also, in South Creek National Park located in Grand Turk, mangroves were affected (confirmed by PAHO);

Image: Impacts on Coastal Environment (Department of Environment and Coastal Resources)
