# Construction and Hazardous Waste Management

Tajikistan

June / July 2015

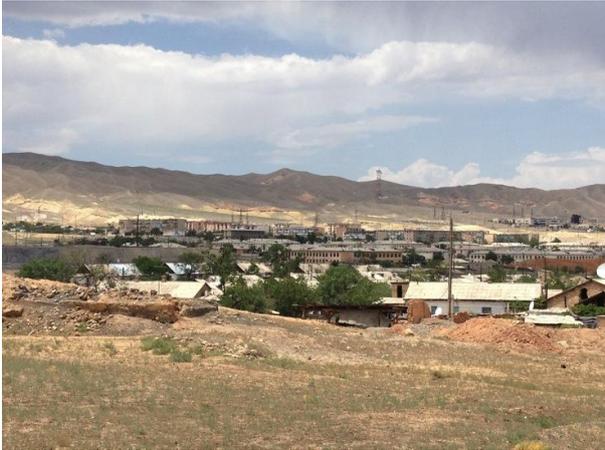
Following the collapse of the Soviet Union as many as two thirds of the residents left, in most cases removing anything of value from houses and other infrastructure. The result is that there are a number of locations in the town which have partially deconstructed buildings and unmanaged waste from destroyed structures. In addition, a number of the remaining buildings in the town are in poor shape and posing immediate threats to neighbours and likely to collapse under minimal seismic activity. Shurob is located in a very active seismic zone.

Figure 1 – Shurob town

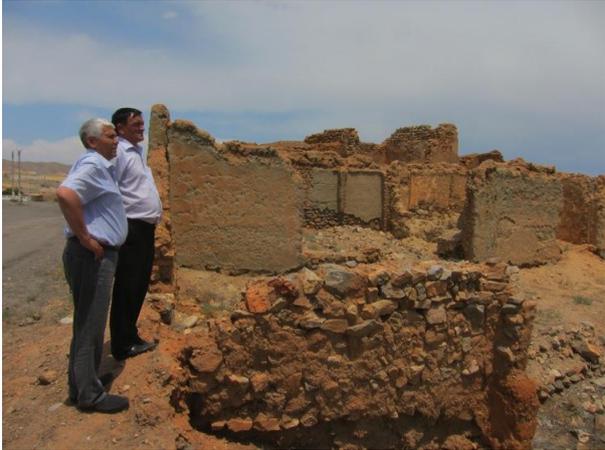
Figure 2 – Abandoned buildings in former Kyrgyz part of the town

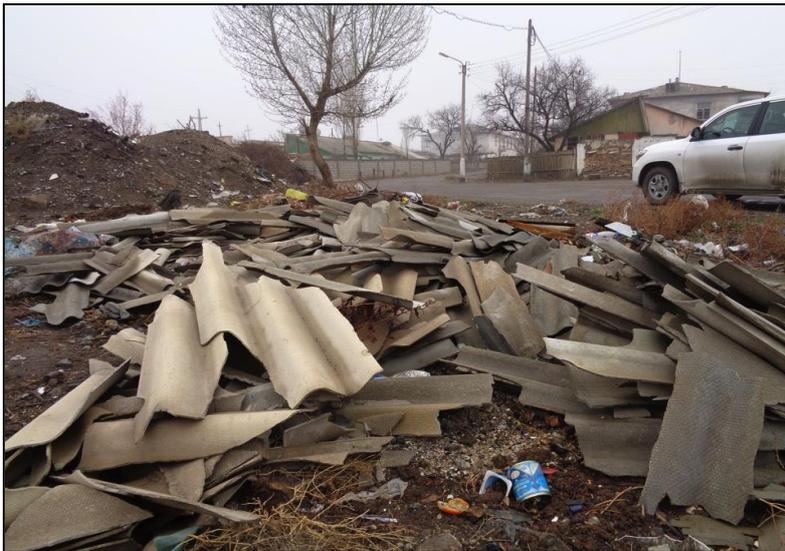
During the initial scoping visit in March 2015 the presence of asbestos within the town of Shurob first became apparent. Considerable quantities of broken roofing-sheets were observed dumped at multiple locations around the town. Further, it was noted that all of the two-storey buildings selected for deconstruction all possessed the same style of roofing-sheets. Visual inspection of the material by the expert raised concerns about the potential presence of white asbestos (Chrysotile) and this was subsequently confirmed by laboratory analysis at an accredited laboratory in the UK.

*Figure 3 – Large quantities of asbestos containing roofing-sheets were observed to be dumped around the town of Shurob*

6. The mission's recommendations to the Shurob municipality are that the following actions are undertaken as a matter of priority:
  1. Commence a programme to remove and safely dispose of all existing asbestos roofing material dumped in various locations around the town, using the equipment provided by the UN (tractor & trailer and wheeled-digger).

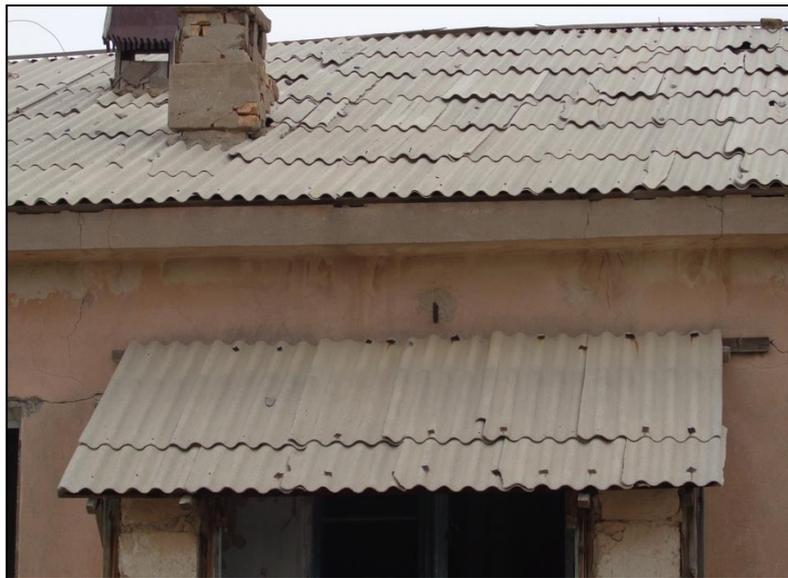
*Figure 4 - it was noted that all of the two-storey buildings selected for deconstruction possessed the same style of asbestos containing roofing-sheets*

Confirming the presence of a large quantity of asbestos containing roofing-sheets throughout the town of Shurob necessitated a change of approach for the proposed deconstruction plan and meant that specialist training, personal protective equipment (PPE) and specific operational procedures needed to be finalized in advance of any deconstruction activities proceeding.

Further, it should be noted that only a selection of two-storey buildings throughout the town of Shurob were inspected by the project's hazardous waste expert as, at the time, these were the focus of the proposed deconstruction works. Consequently, a more extensive asbestos survey is required to determine the presence, or otherwise, of other types of asbestos containing materials such as that contained within pipe and boiler lagging which may be of a higher risk to public health due to the potential presence of the more hazardous blue and brown asbestos (Crocidolite and Amosite).

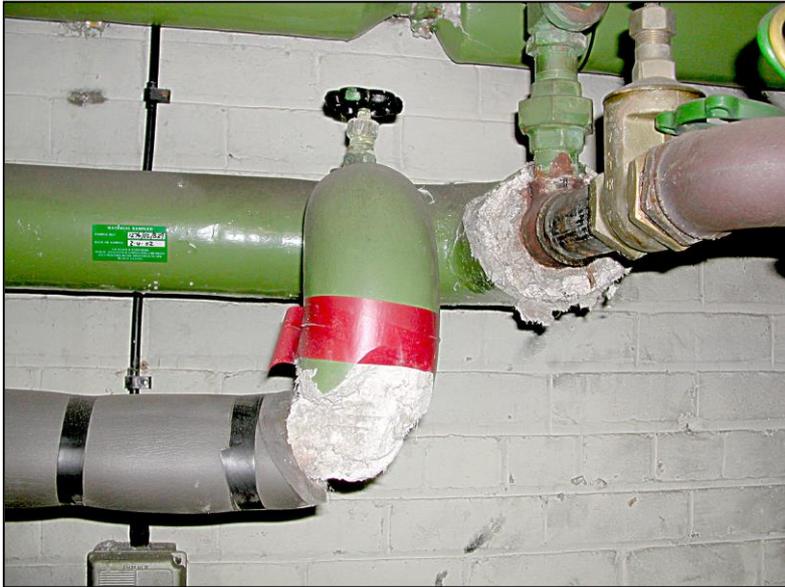
Blue and brown asbestos (Crocidolite and Amosite) is often used in hot-water pipes, boiler and tank insulation and is considerably more hazardous than the white asbestos (Chrysotile) typically contained within roofing sheets. Typically, blue and brown asbestos is found in basement areas of properties.

*Figure 5 – A comprehensive asbestos survey is required to determine the presence of other, potentially more hazardous, sources of asbestos throughout Shurob. Note that this image is for information purposes only and not taken in Shurob.*

9.	Undertake Comprehensive Asbestos Survey	<p>5. Having confirmed which buildings should be deconstructed via the completion of the necessary structural surveys, complete a comprehensive asbestos survey to identify all asbestos (paying particular attention to the higher risk asbestos containing sprayed coatings typically found in basements around hot-water piping, boilers and tanks) and develop an Asbestos Management Plan and a Health &amp; Safety Plan.</p> <p>6. If necessary, seek assistance from the international community for providing and funding of suitably qualified asbestos experts.</p>	6-18 months	Shurob Municipality

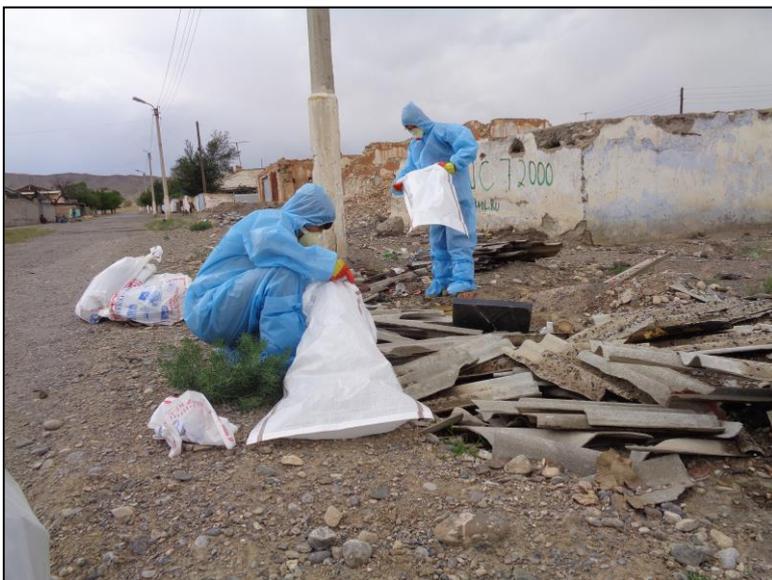
*Figure 6 – Participants gained experience in the field of handling, containing and disposing of asbestos waste.*

The second day of training focused on asbestos including the differing types of asbestos and its varied uses; identification of asbestos; handling, transportation and final disposal requirements. Training participants engaged in group exercises during which they applied their new found skills in relation to asbestos handling, containment and disposal activities.

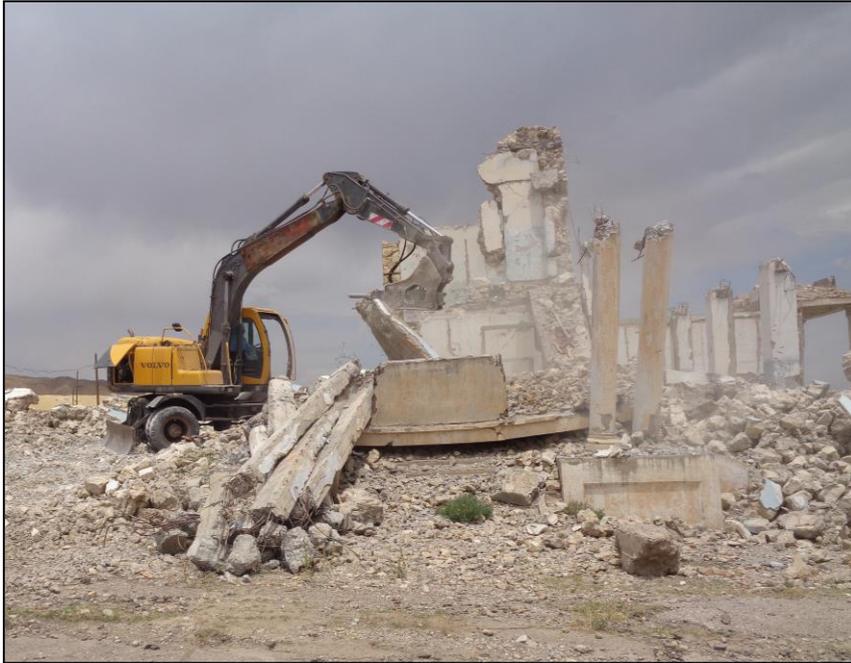
Additionally, demolition work was initiated within the pre-selected clearance site using heavy equipment on loan from the adjacent mine. During this phase of the programme participants learnt about the risks of working in proximity heavy equipment, measures to suppress health nuisances such as excessive dust generation. Also, participants got to wear the full range of PPE.

*Figure 7 – heavy equipment was sourced from the adjacent mine to commence demolition works.*

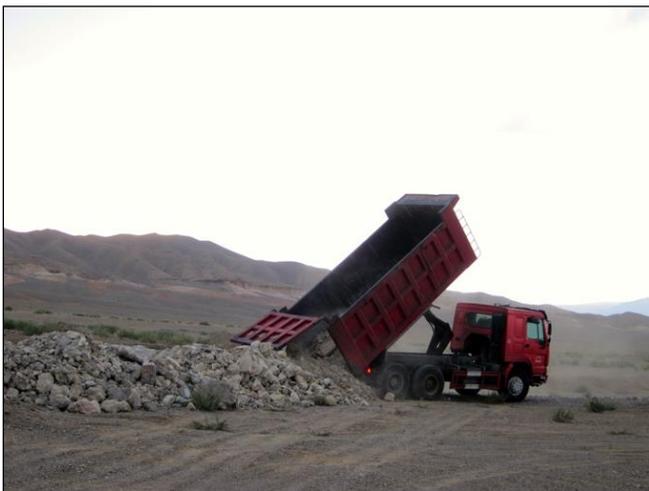
*Figure 8 – Construction rubble, from which asbestos has been removed, is used to expand town flood barrier.*
