UNDAC Environmental Emergency Assessment
Ammunitions Depot Explosions
Brazzaville, Congo
March 2012

Executive summary

2 Assessments and Findings

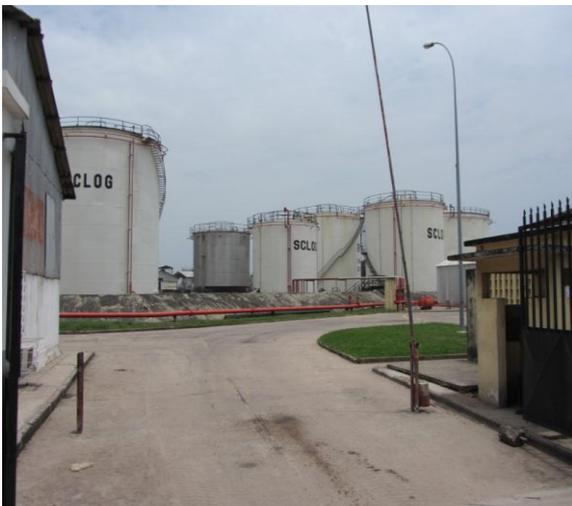
SCLOG Storage Facility

The first field observation took place at a hydrocarbon storage facility (04°6,00'74"S/15°17,47'76"E) operated by the Société Commune de Logistique Pétrolière (SCLOG). Due to limited access, observations were made outside of the installation perimeter. Fifteen hydrocarbon tanks, each of 4,000 m³ in size, were observed to be in good condition and well maintained. The industrial installation was fully operation and well secured, with no detectible damage.

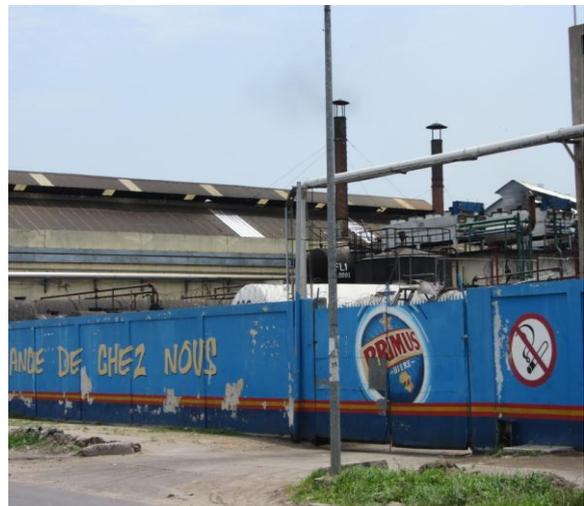
The second field observation occurred at Brewery Brasco (04°15,33'14"S/15°17,54'13"E), where limited damage to the roofs of the buildings was observed, though repairs were in progress. There was no visible damage to the vertical and horizontal tanks of fuel and compressed gas, and no visible damage to the network of pipes. The installation was well secured.

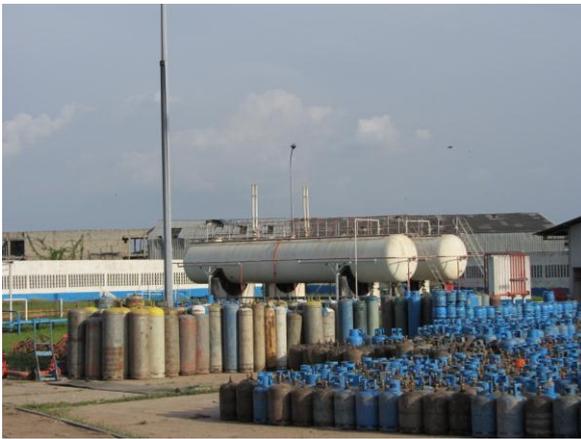
The fourth site visit occurred at LPG Storage and Distribution (04°15,14'88"S/15°17,52'94"E) where noticeable damage to the roofs of buildings was detected. No visible damage to the small storage cylinders or horizontal tanks was visible, and the pipes and equipment were determined to be intact. The activities and installation were well secured.

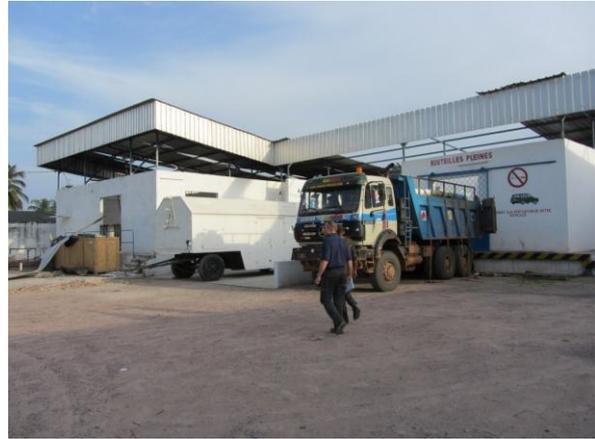
The final location observed was the property of Air Liquide (04°15,71'90"S/15°17,48'72"E), a temporary storage and redistribution site for compressed gas cylinders. Limited damage to the roof of the building was observed, but no visible damage to the storage cylinders was present.

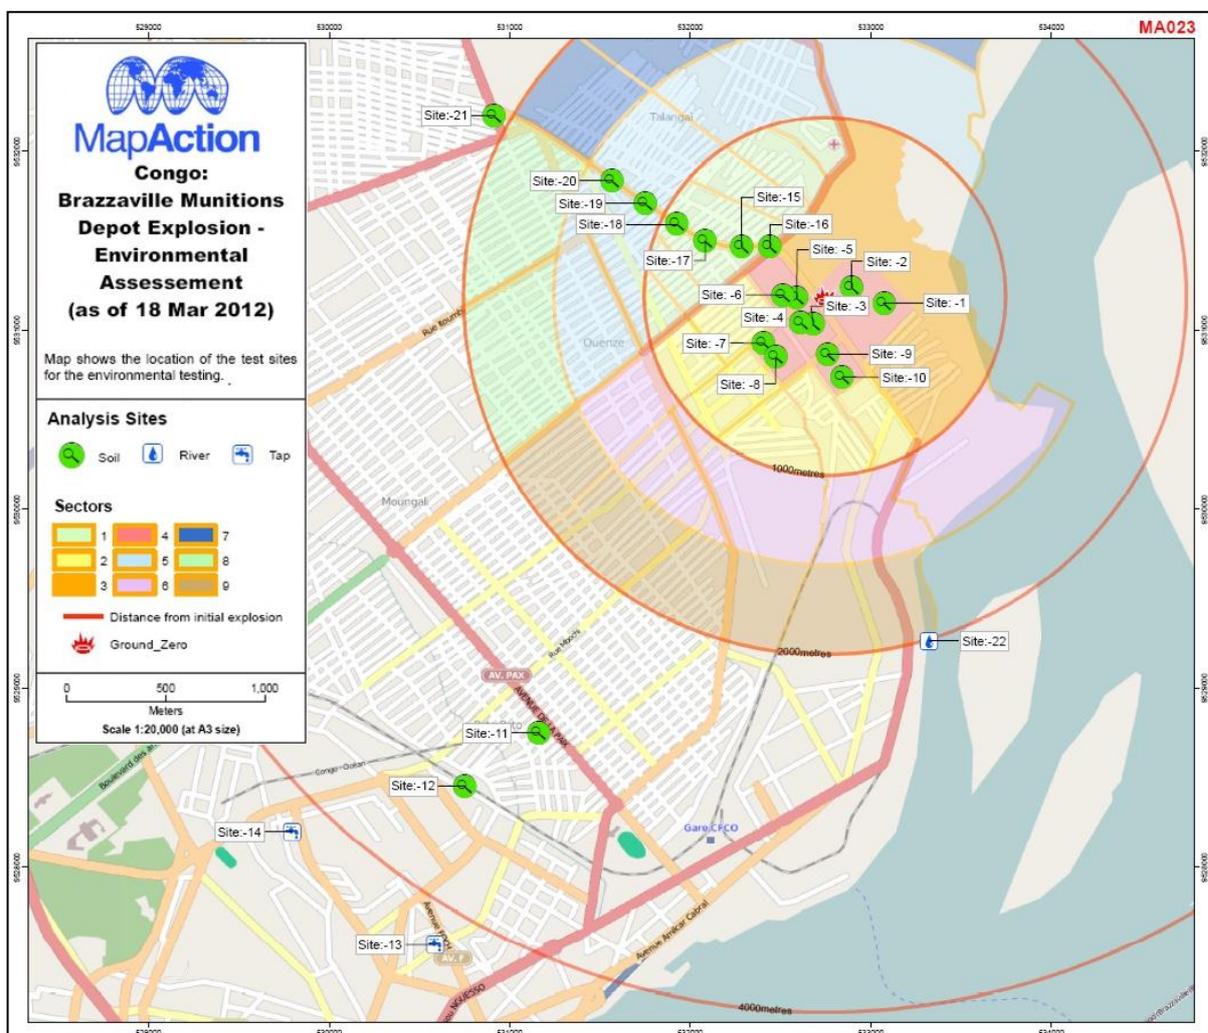
Therefore, water and soil samples were taken from 22 sites reflected in the above map (See Annex I for detailed location information). Ten soil samples were taken from the impact zone by a de-miner from the NGO Mines Advisory Group (MAG). Seven samples were taken along an axis 2km in length, beginning at the fence of the impact zone. Two additional samples were taken from reference points presumably not affected by the plume.
