Environmental Emergency Response to the Lebanon Crisis

Consolidated report on activities undertaken through the Joint UNEP/OCHA Environment Unit

November 2006

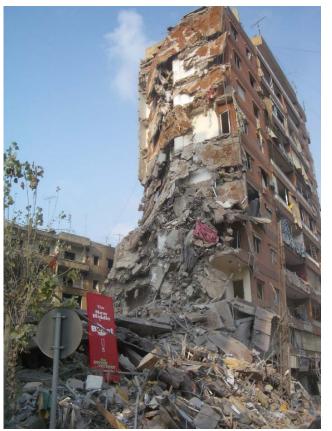
A rapid waste assessment helped determine identify the composition of waste and supported response planning. Source: R. Nijenhuis

Table 1. Estimate of debris composition from rapid waste assessment		
Concrete	50-70%	
Steel/iron	5-8%	
Bricks	10-25%	
Other metals	2-5%	
Plastics (including foam)	5-15%	
Organic waste (including food)	2-8%	
Hazardous waste	<2%

Based on this assessment, recommendations were made to the Ministry of Environment for the establishment of a temporary waste recycling and storage sites in order to promote the recycling of various waste streams. The objective was to reduce the pressure on natural resources, including the negative impacts of guarrying in Lebanon.

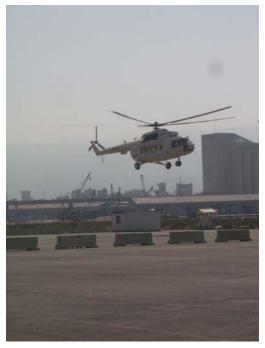
A helicopter departs for surveillance to support oil spill response planning. Source: R. Nijenhuis

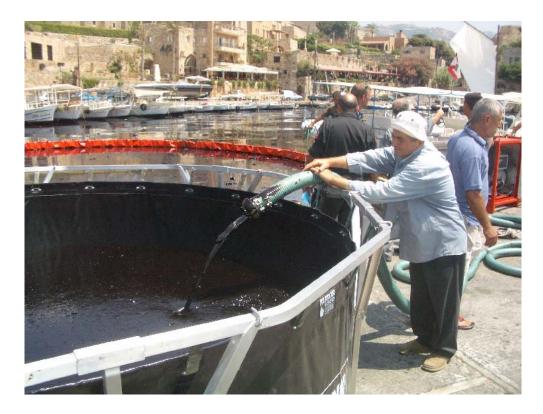
Oil spill clean-up activities in Lebanon: acute needs have been met, but longerterm challenges remain. Source: R. Nijenhuis
