# Rapid assessment of acute environmental risks after Hurricane Dorian

**The Bahamas**  
**September 2019**

**JOINT  
ENVIRONMENT  
UNIT**

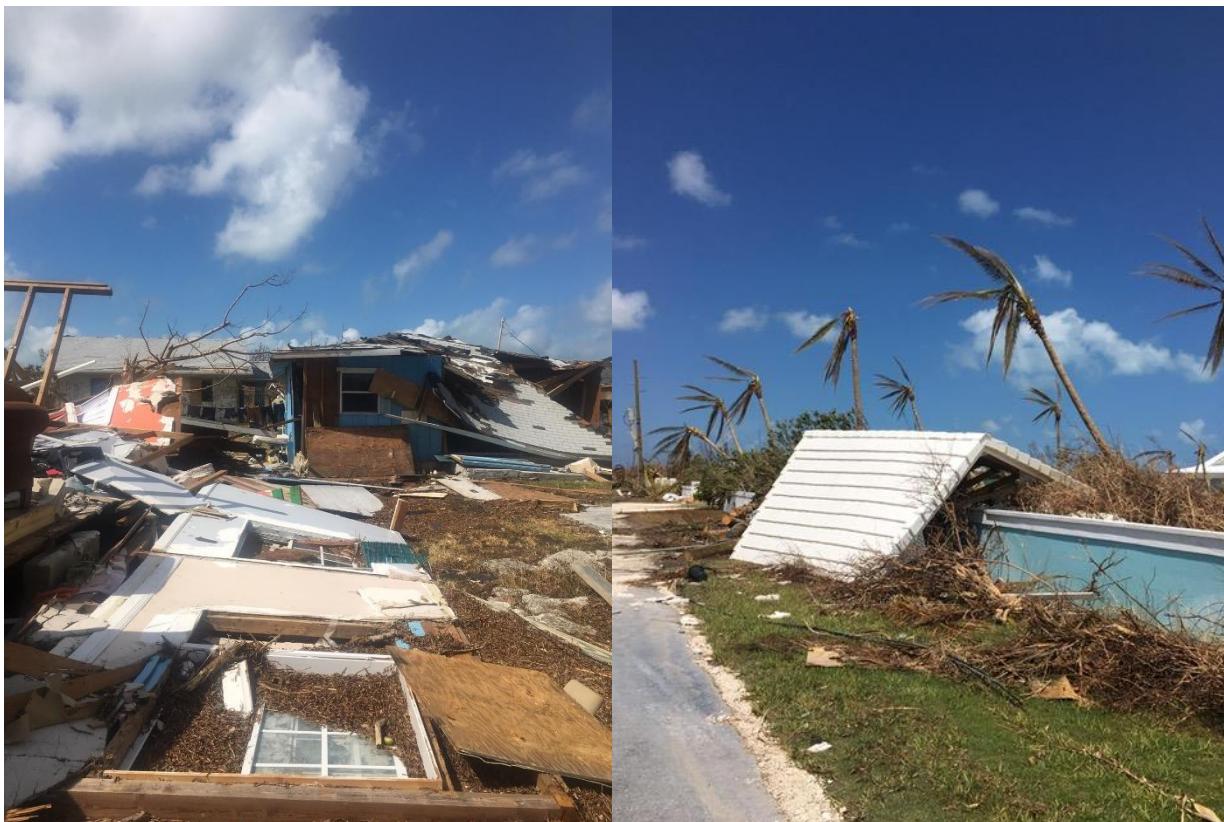
In particular, the hurricane generated large quantities of disaster waste. Aerial footage of the affected areas as well as site surveys show widespread disaster waste (Figures 1 and 2), including hazardous waste that requires adequate disposal. Disaster waste threatens human health, hinders recovery and reconstruction efforts and can significantly impact the environment.

*Figures 1 (left) and 2 (right): disaster waste generated by Hurricane Dorian on Abaco Islands*

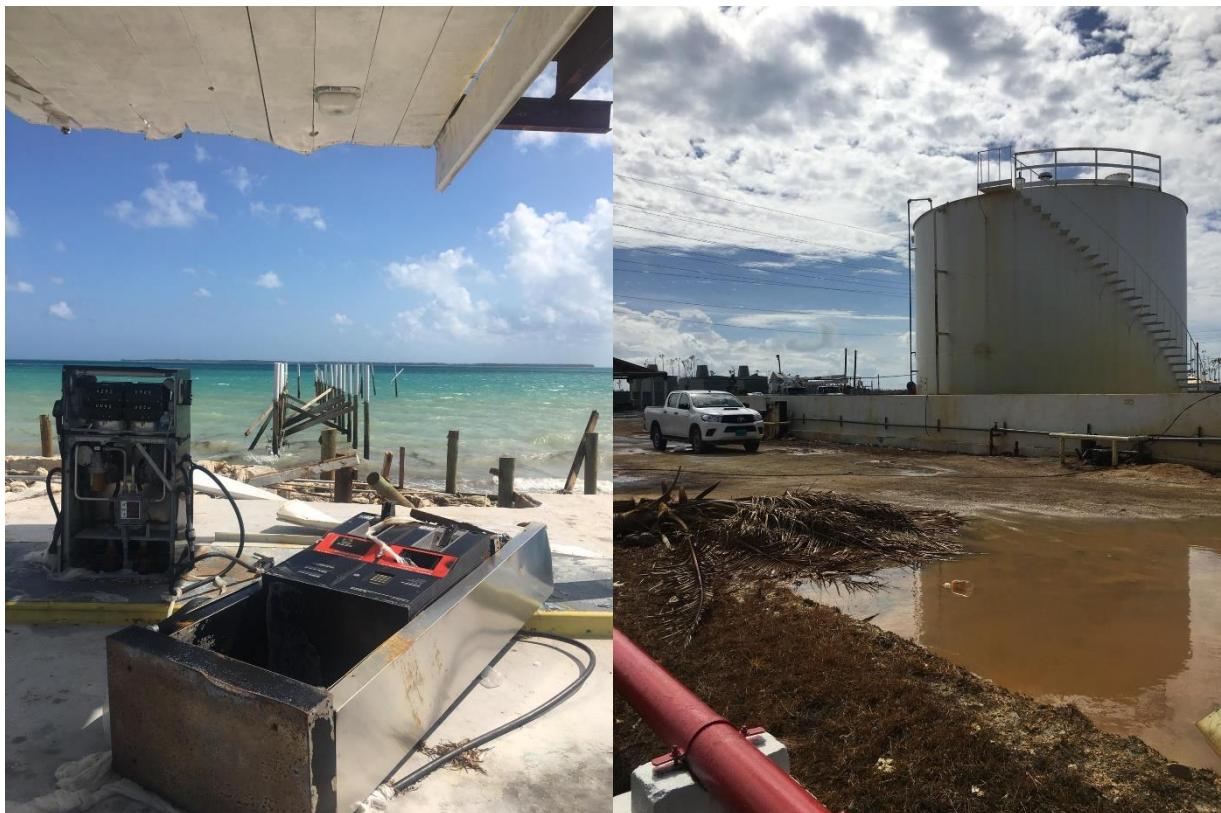
Several hazardous operation facilities are located on Abaco and Grand Bahama Islands, many of which were severely impacted by Dorian (Figures 3 and 4), leading to the generation of hazardous waste and with potential for additional negative impacts to human health, livelihoods and the environment.

*Figures 3 (left) and 4 (right): damaged gas station in Cooper's Town, Abaco Islands (left); diesel fuel leak at Marsh Harbour power sub-station (right)*

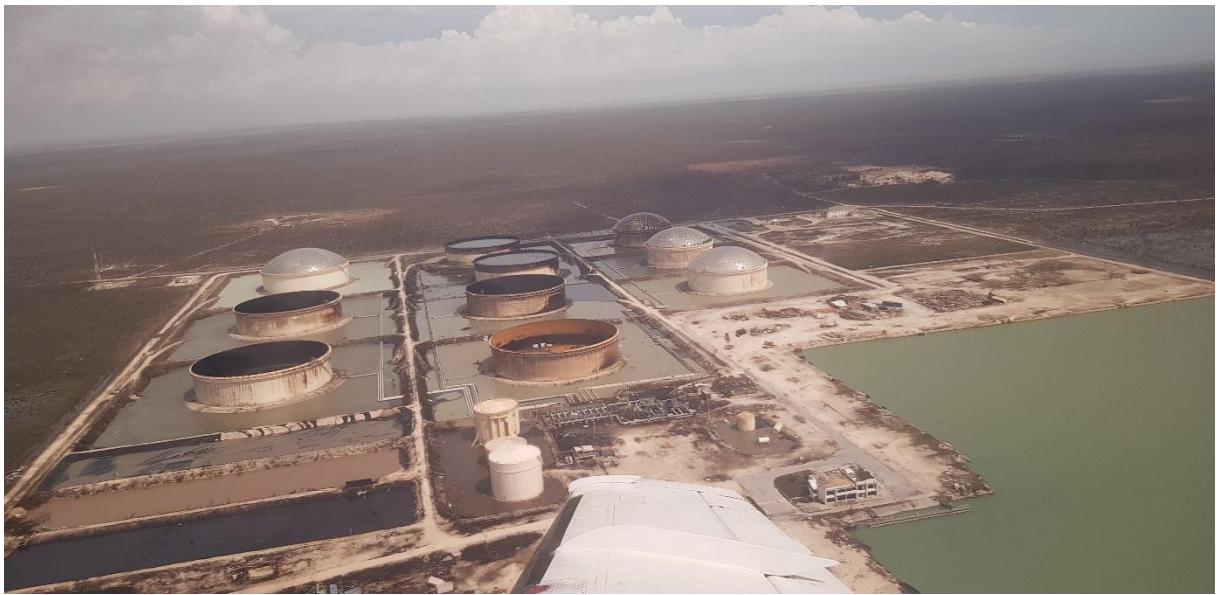
Dorian significantly impacted one of two oil storage facilities located on Grand Bahama Island, with a confirmed inland spill of crude oil from Equinor's South Riding Point terminal. Operations at the terminal were shut down on 31 August as a precautionary measure in view of the hurricane warning. On 5 September, Equinor reported<sup>2</sup> that the facility had sustained damage based on findings from preliminary aerial assessment. An inland spill of crude oil towards the northeast was confirmed and noticeable from photo evidence made available by PAHO after an aerial assessment conducted on 4 September, further to the all-clear (see Figure 5 below). The operator subsequently engaged oil spill response resources to respond to the event and initiate the clean-up.

Figure 5: Inland spill of crude oil from Equinor oil storage facility as of 4 September 2019 (© PAHO)
